CABOOSE The CLASSICS

THE N. Y. C. "STANDARD" CABOOSE

THE CLEVELAND, CINCINNATI, CHICAGO & ST. LOUIS CABOOSE

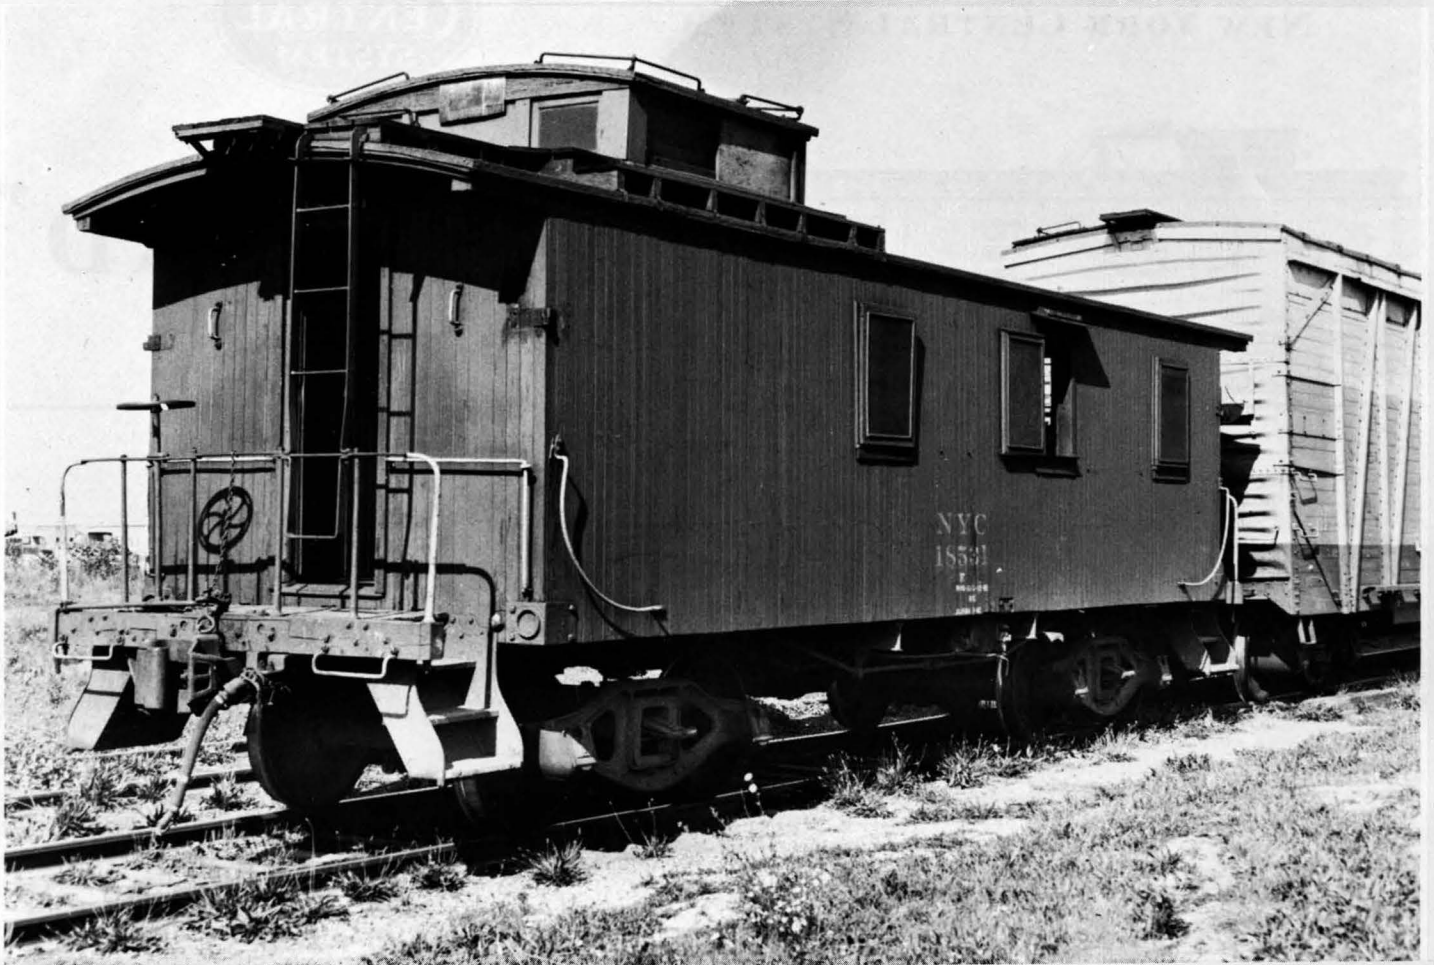
Although approaching 50 years of service, caboose #18531 still manages to look dignified despite having had its cupola boarded up. As modern freight cars grew in height, the short cupolas no longer provided train crews with the vantage point that they once did in years past. Caboose and a local freight are shown at Sandusky, Ohio in 1964.

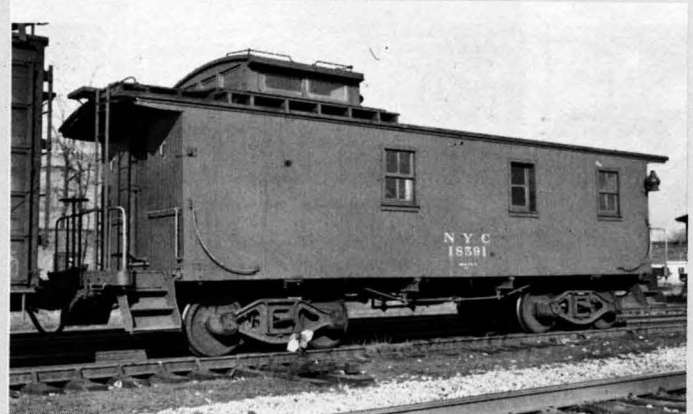
Caboose #18591 at Conneaut, Ohio on November 21, 1946. No N. Y. C. herald appears above the "roman" style lettering but handrails have been painted yellow.

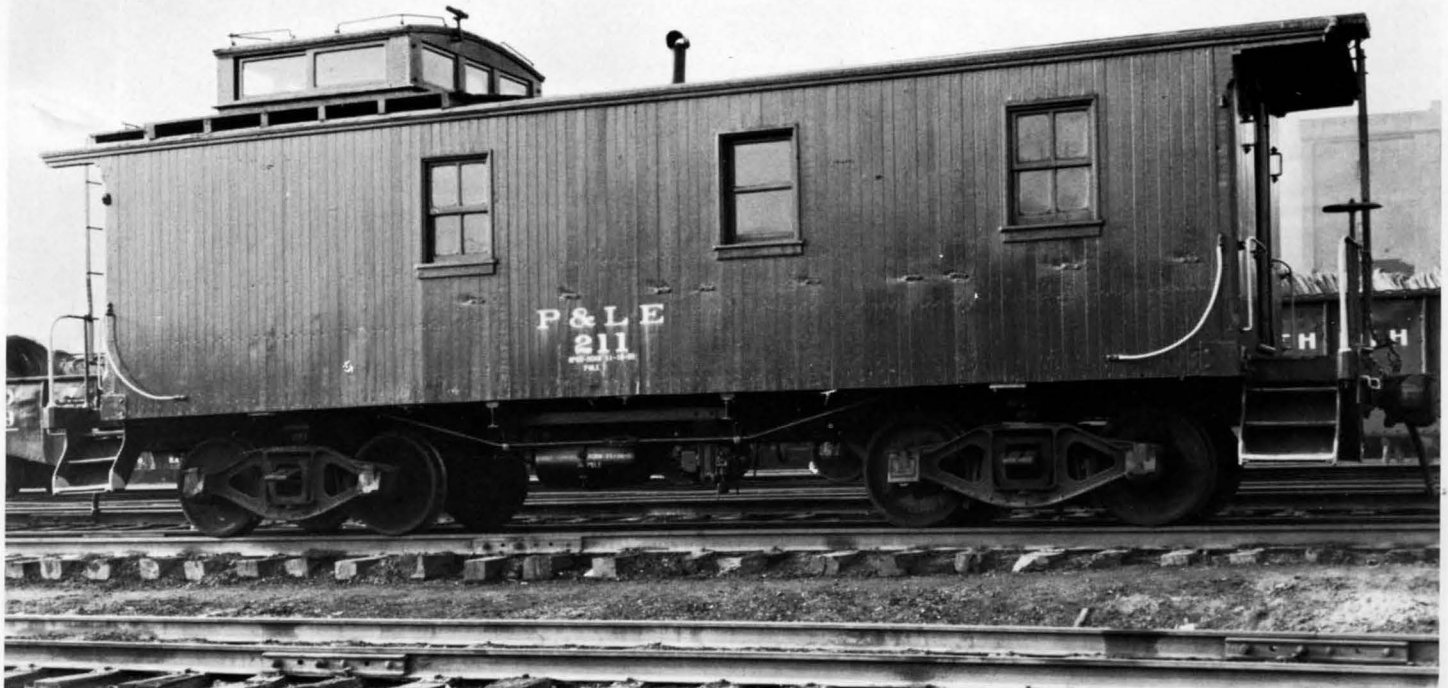
The "standard" caboose was also used by the Pittsburgh & Lake Erie. Caboose #211 was built at P. & L. E.'s own shops at McKees Rocks, Pa. in 1925-26 as part of lot #470 which consisted of 34 cabooses, #200 thru 233. Also part of this same caboose order were 21 cabooses built for the Pittsburgh, McKeesport & Youghiogheny R. R. numbered 150 thru 170. The P. McK. & Y. was leased to the P. & L. E. for 999 years in 1881

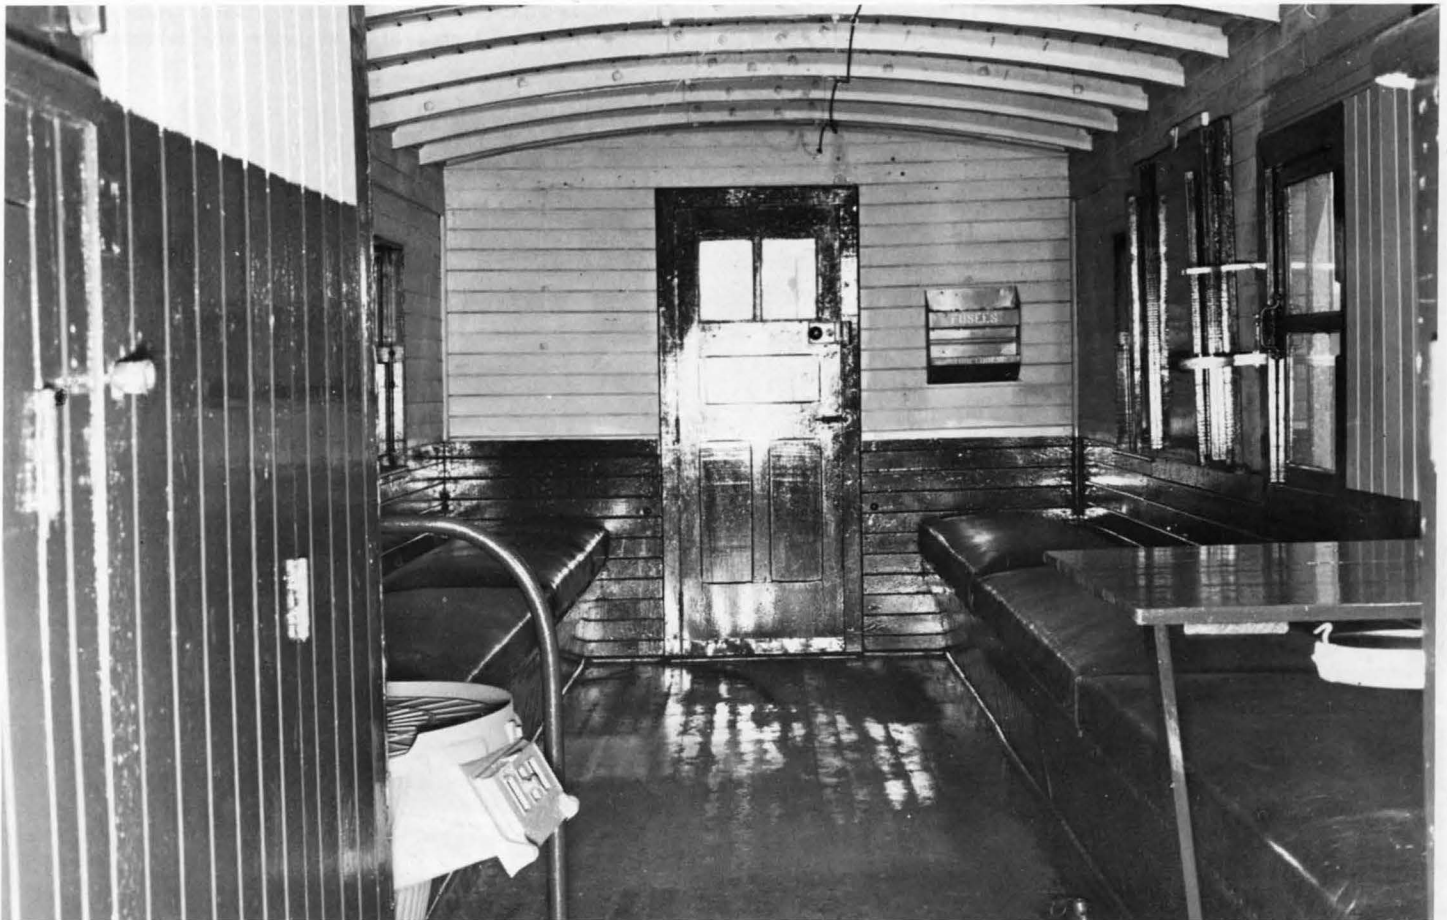
Interior of P. & L. E. Caboose #211. View shows "long end" of caboose from underneath cupola. All N. Y. C. S. "Standard" caboose interiors were similar. Note folding table at right with coal stove and safety guard rail showing at left.

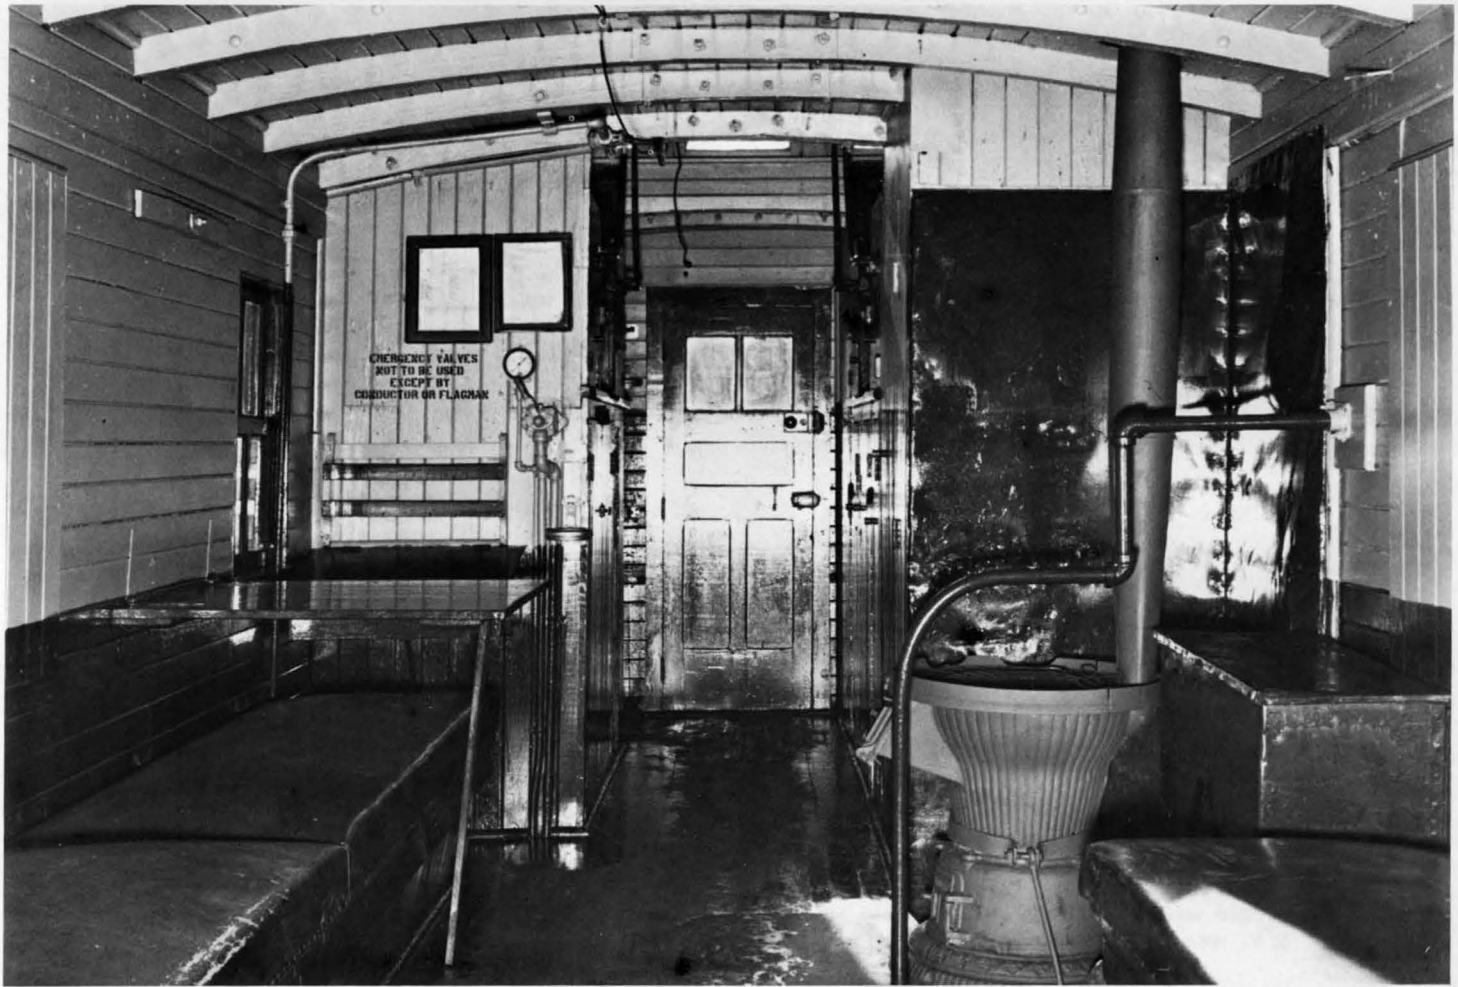
Interior view of P. & L. E. caboose #211 taken from long end of car. Note coal box and metal heat shield behind stove area. Fire was an ever present danger in wood cars with coal stoves. Air brake controls and gauge are mounted on bulkhead of storage locker and cupola seats.

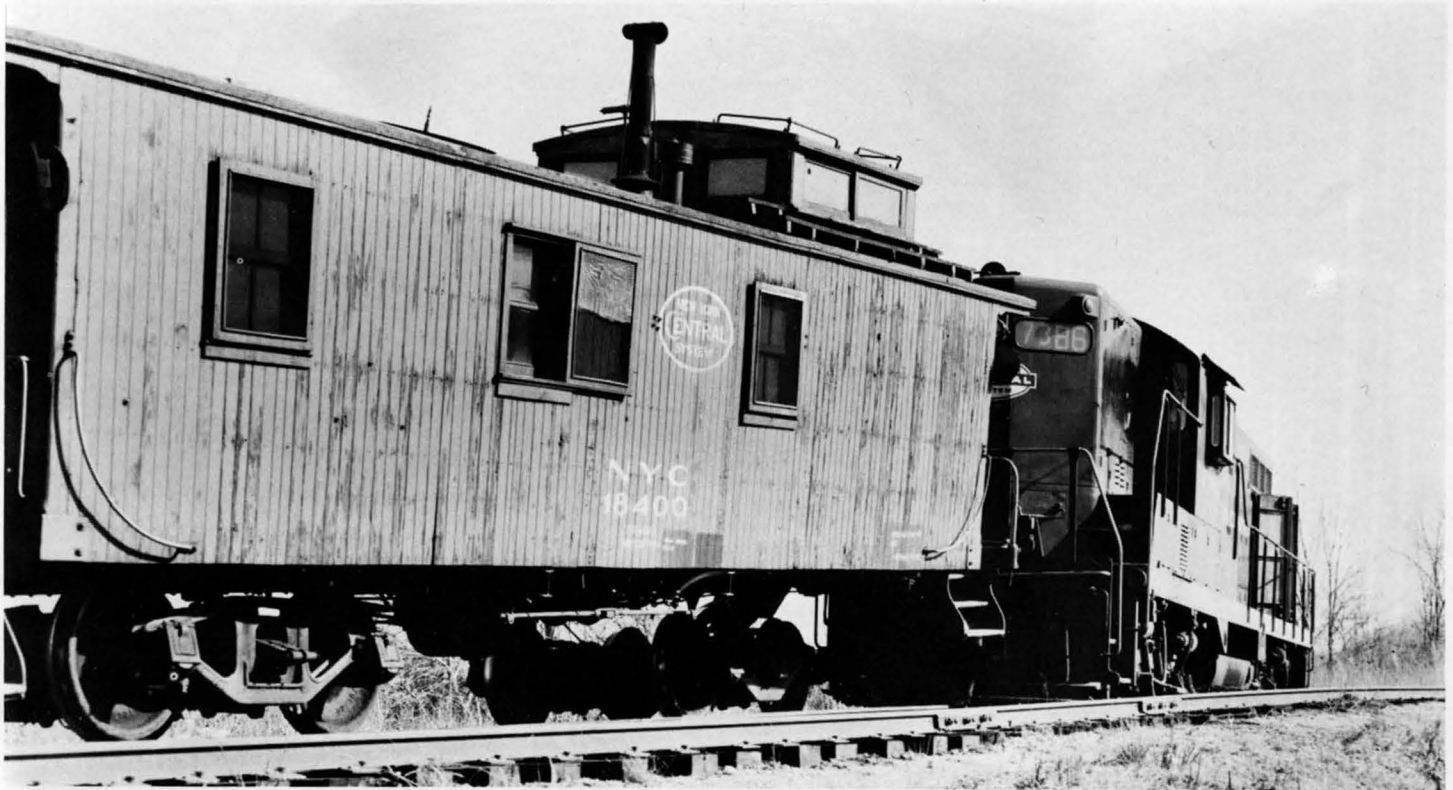
When a locomotive gets into trouble, can a caboose be far behind? N. Y. C. #18400 is pulled off the track by GP-9 #7386 near Fremont, Ohio on February 3, 1968. This mishap probably ended 18400's long career which began when it was built at Oswego, N. Y. in 1916. The "geep" has been renumbered from 5986. Photo by Bob Lorenz

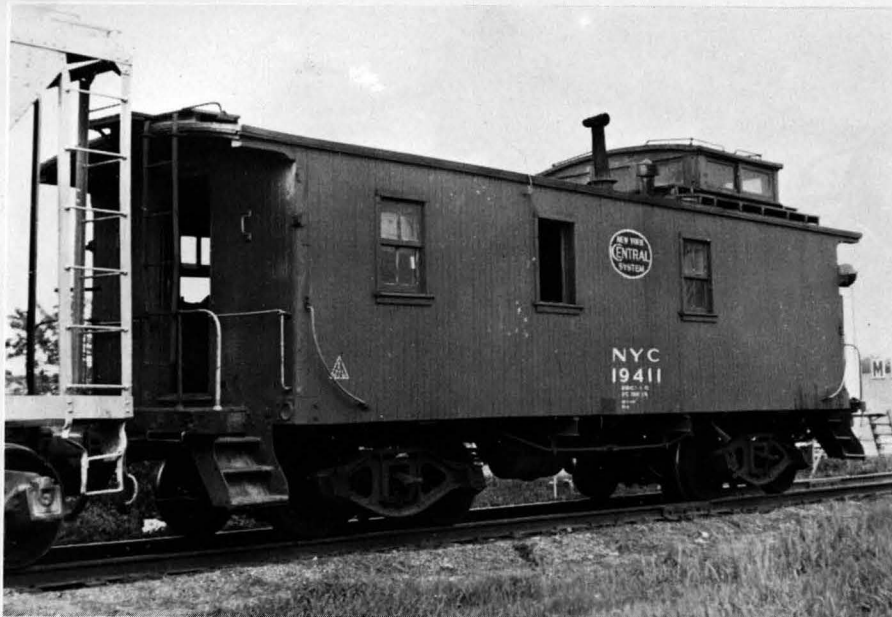
A whip antenna for the train crew's radio is mounted just outside the open center window of caboose #19411 at Fremont, Ohio, in May, 1964. Note the more modern "gothic" style lettering and black painted background of the N. Y. C. oval herald.

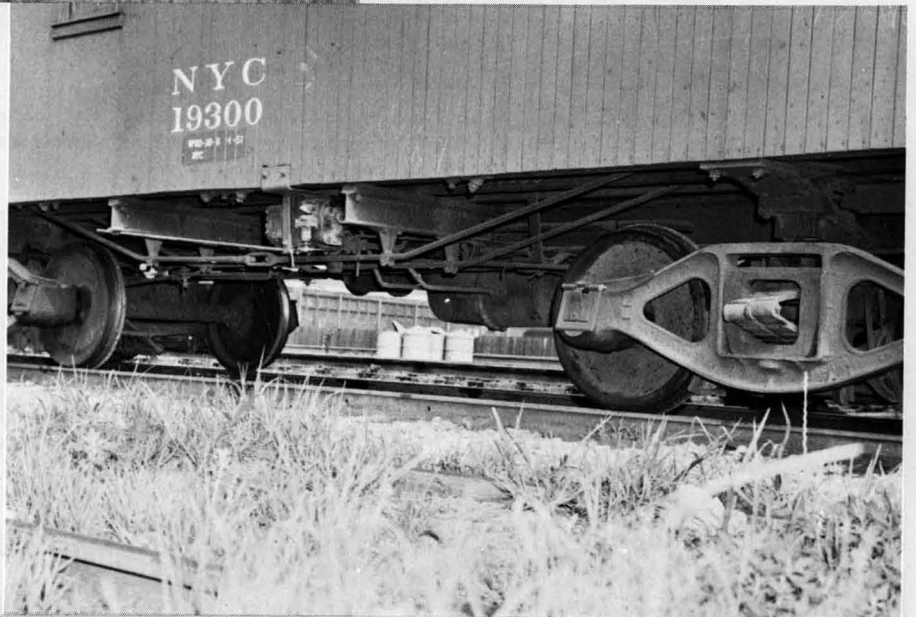
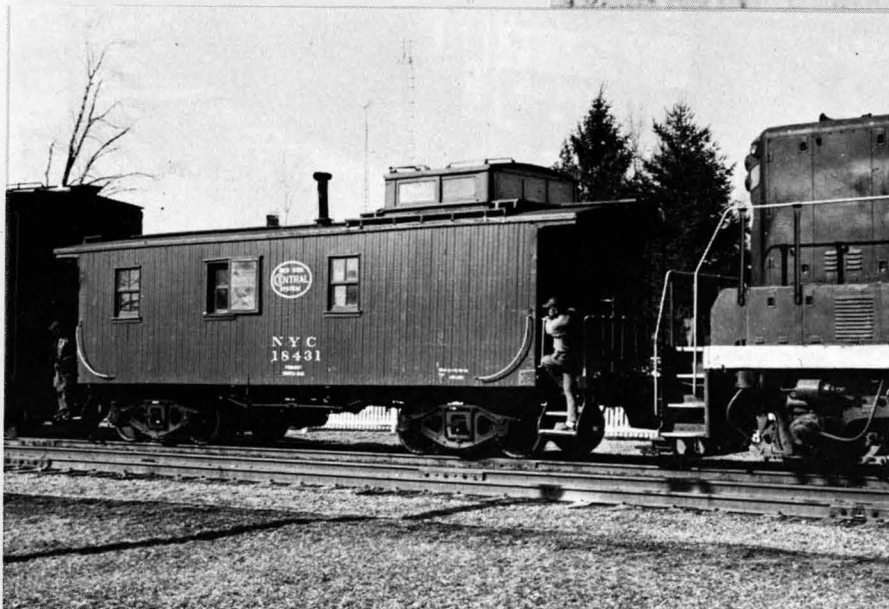
Although N. Y. C. caboose bodies were made of wood, they were either built or rebuilt with heavy steel underframe as evidenced by this view. Truss rods helped secure body mounting, but were not relied upon for principal support.

A switching move at Fremont, Ohio finds caboose #18431 and crew setting out cars on April 15, 1965. The end windows of the cupola have been boarded up but the car still looks good despite its 49 year seniority on the N. Y. C. which began at Oswego, N. Y. in 1916.

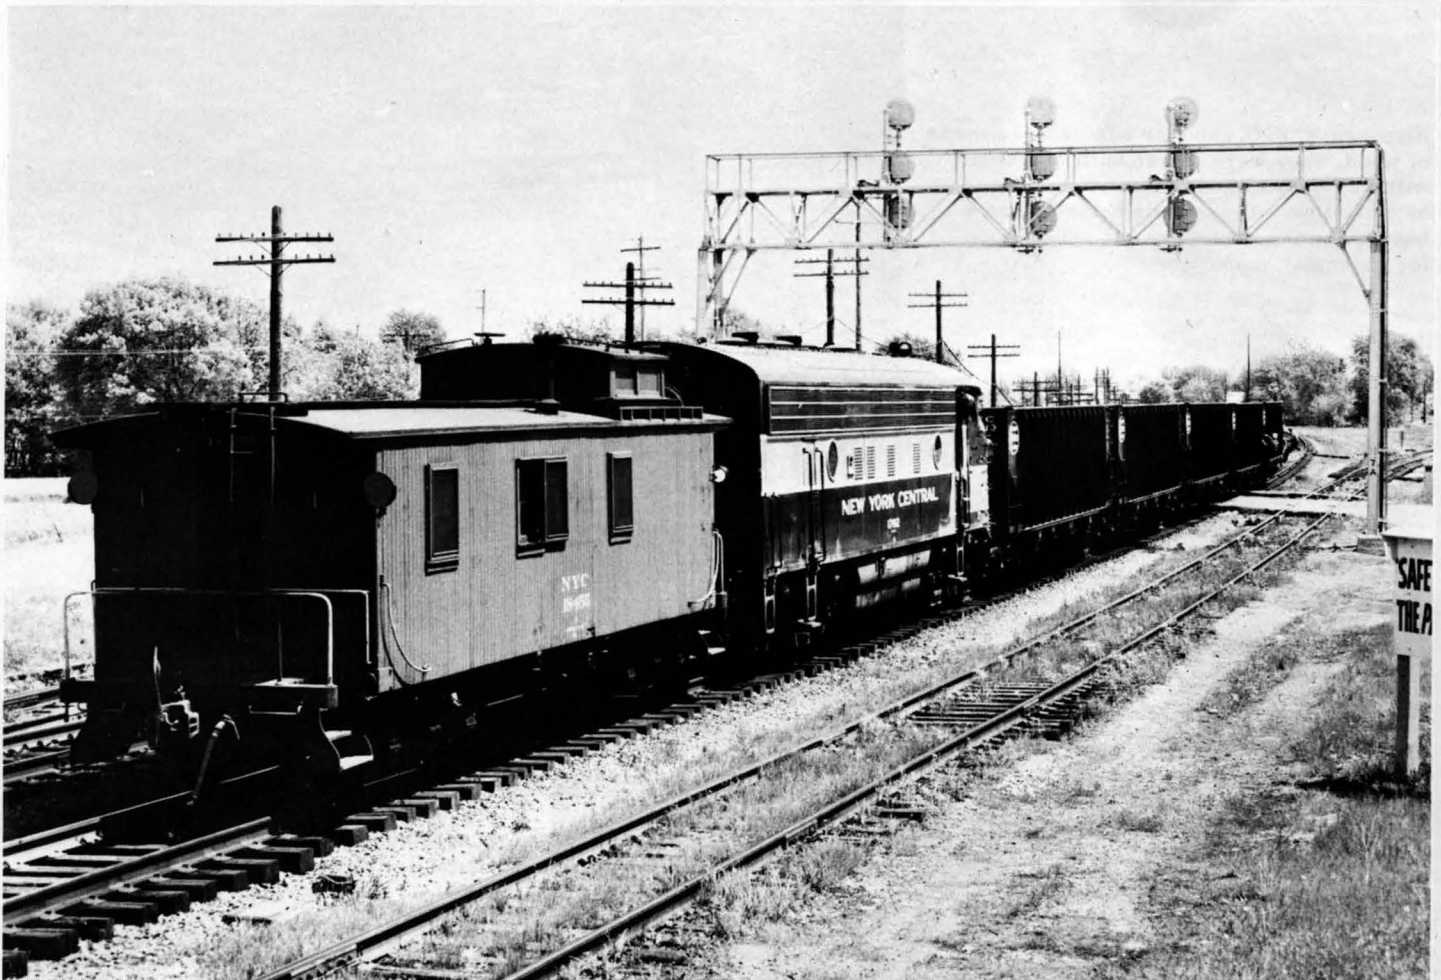
E. M. D. F-7A #1702 and caboos #18455 team up to get some hopper cars moved at Millbury, Ohio in July, 1961. This caboos had a long useful life, being built at Collinwood, Ohio as part of an order built between 1901-1910. Notice that reflective metal discs have replaced the kerosene marker lamps, once standard equipment on all N. Y. C. caboos prior to the 1960's. Photo by Bob Lorenz

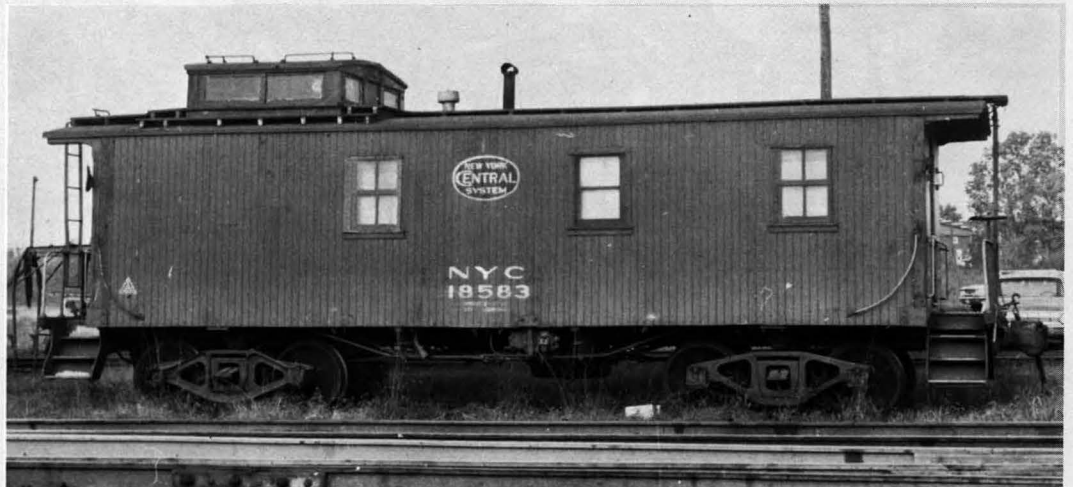
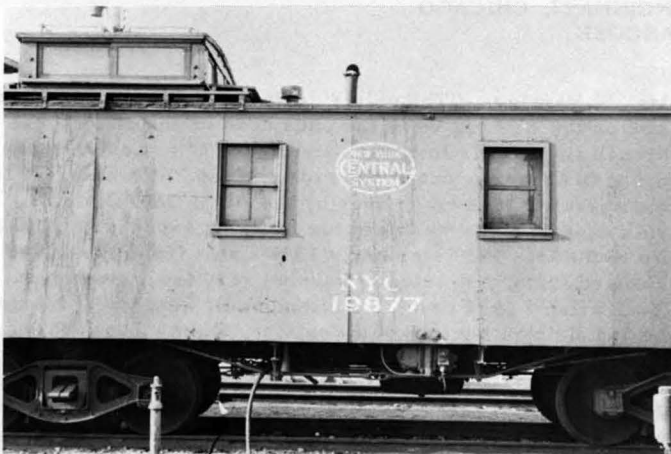
Caboose #18583 shows location of stove smokepipe and vent for the "dry hopper" toilet, whose use could hardly be considered "featherbedding." The truck at the left, under the cupola end of the caboose was the older style "T" section swing motion truck used on N. Y. C. cabooses for many years. The other truck side frame is more modern, having a "U" section casting. Built at Collinwood, Ohio in 1910. Harold K. Vollrath Collection via Carl Prisco

In later years of wood caboose operation, when the tongue and groove siding rotted out, it was covered with plywood sheeting as shown here on #19877 at Niagara Falls, N. Y. at the late date of May 1973. Peter C. Zayau Collection

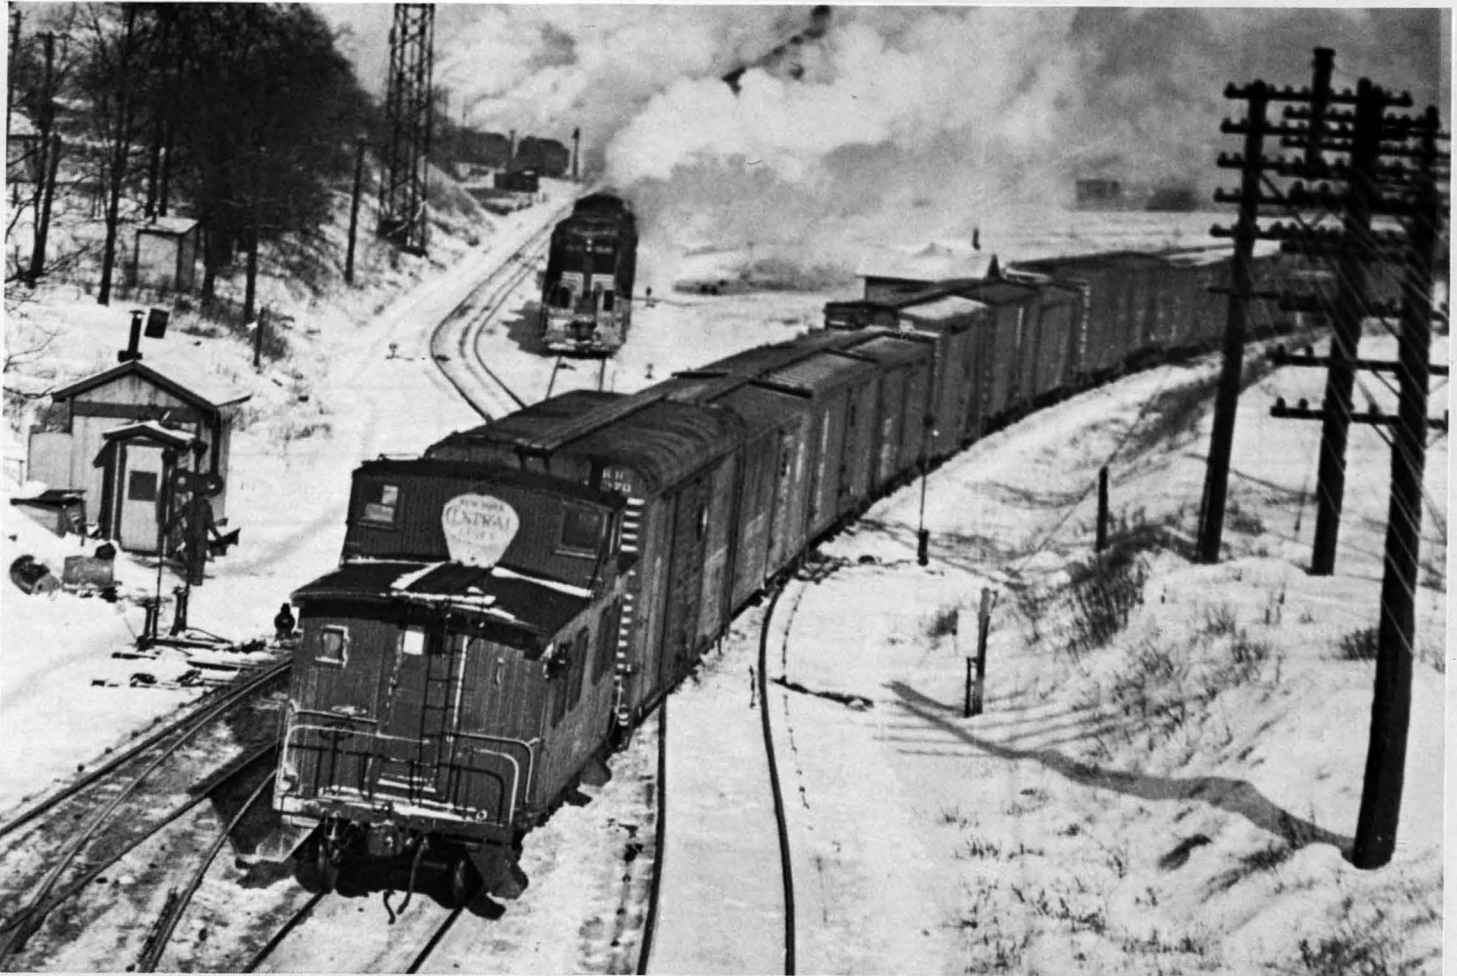
On a cold winters day in January, 1951, a Big Four caboose passes the Sandusky St. shanty heading east on freight SLD-2 from Bellefontaine, Ohio. The "New York Central Lines" herald that is mounted on the end of the cupola was a non-standard marking probably applied by the train crew to help locate "their" caboose in a crowded yard. Si Herring Photo

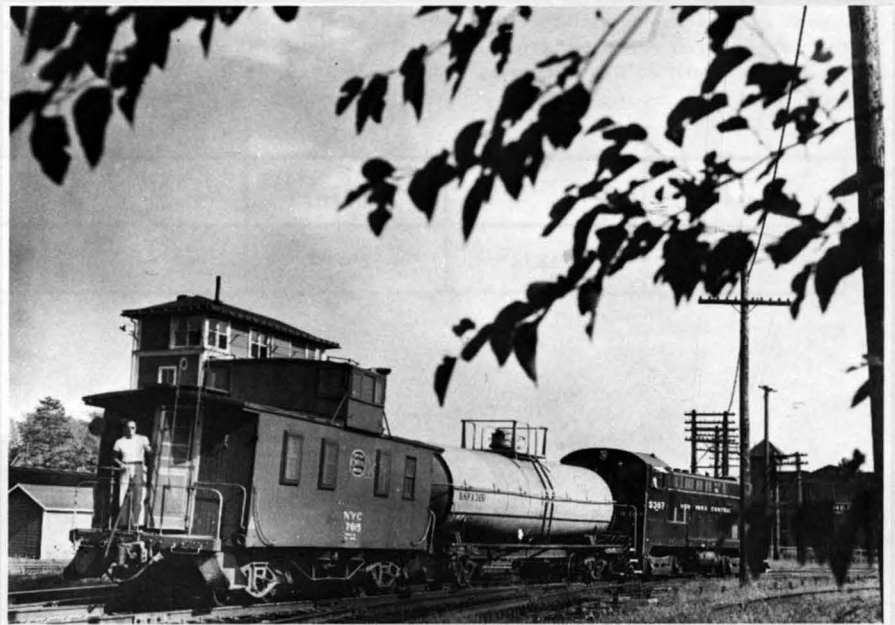
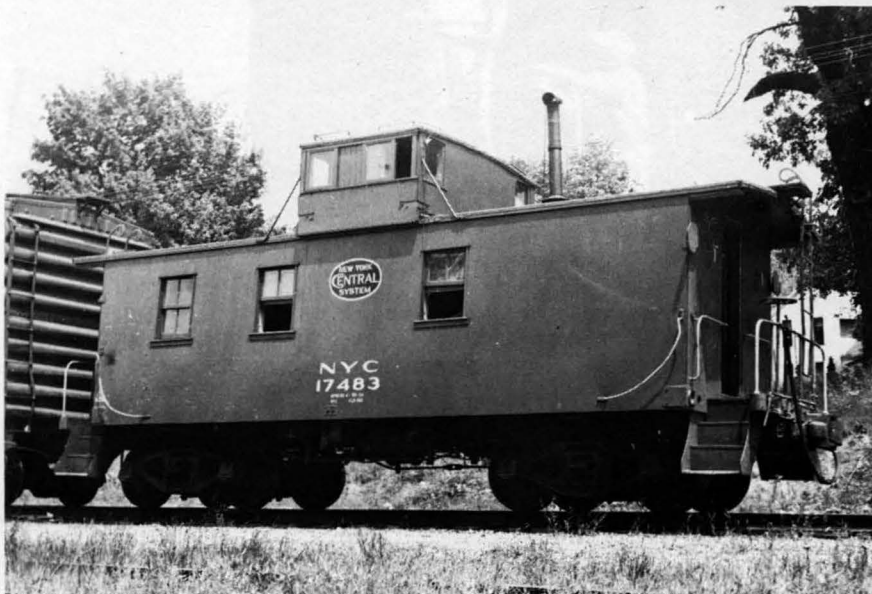
The Big Four cabooses also got the plywood sheathing "treatment" as required in later years as evidenced by #17483, shown at Constantine, Michigan in July 1964. Notice the external cupola braces necessary for the large size cupola.

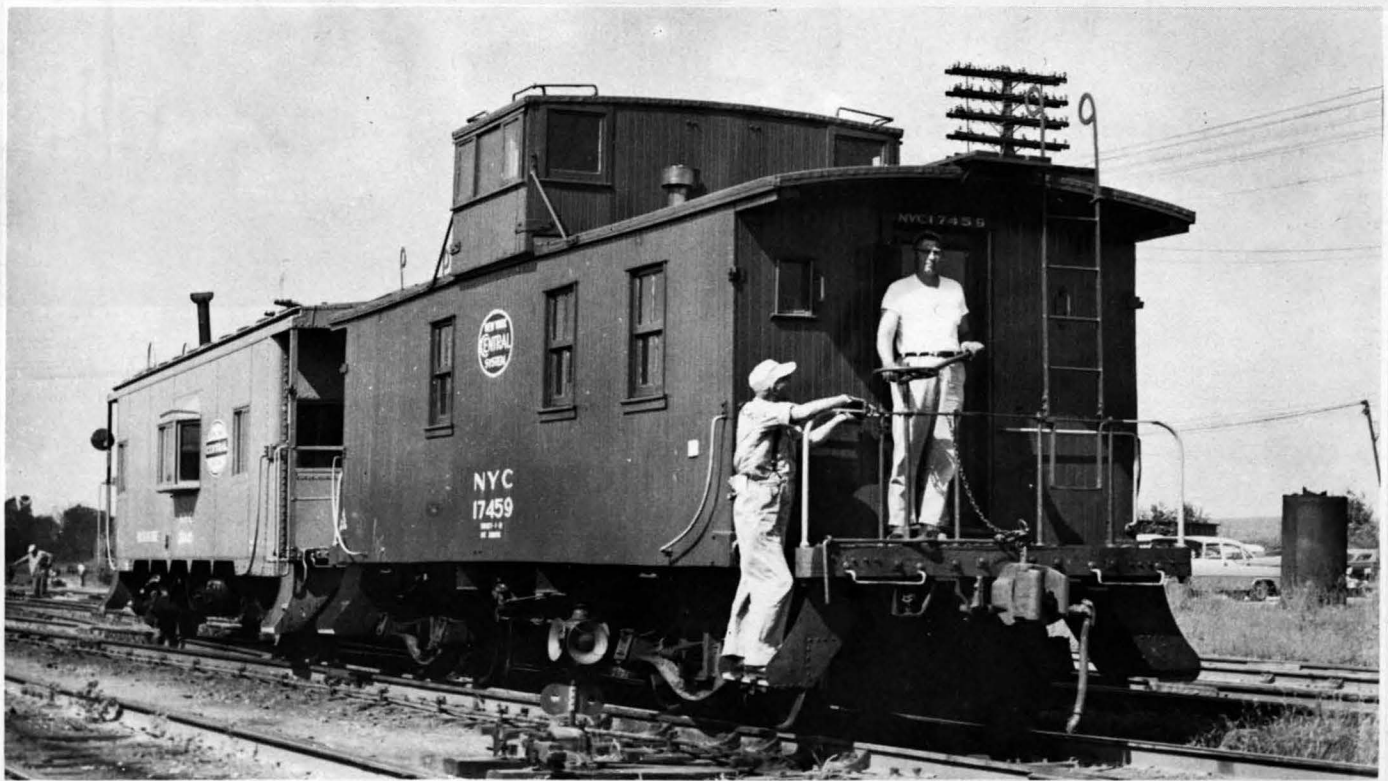
The old and the new. Caboose #17459, freshly painted box car red, has one of its side windows boarded over. Note small window appearing on the left side of the caboose end. No. 17459 has been kicked by a yard engine and is rolling towards the caboose track along with a jade green bay window caboose. Yard conductor J.D. Marker prepares to set the brakes on a warm March day in 1962 at Bellefontaine, Ohio.

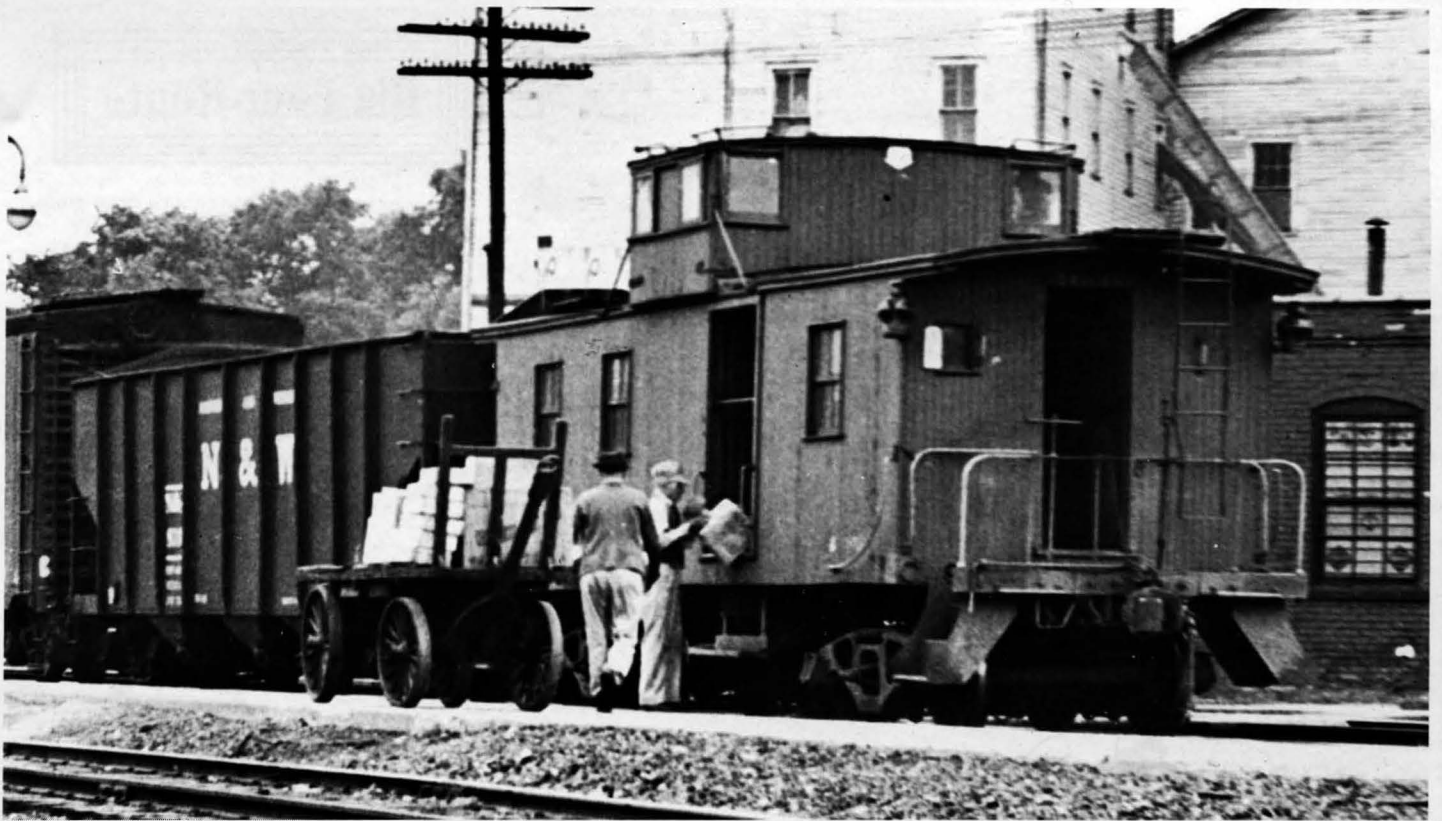
A rare Big Four caboose rebuilding featured a side door, shown here being loaded with l. c. l. freight at Bellefontaine, Ohio in 1948. Train was the T. & O. C. St. Marys Local 554. Si Herring Photo

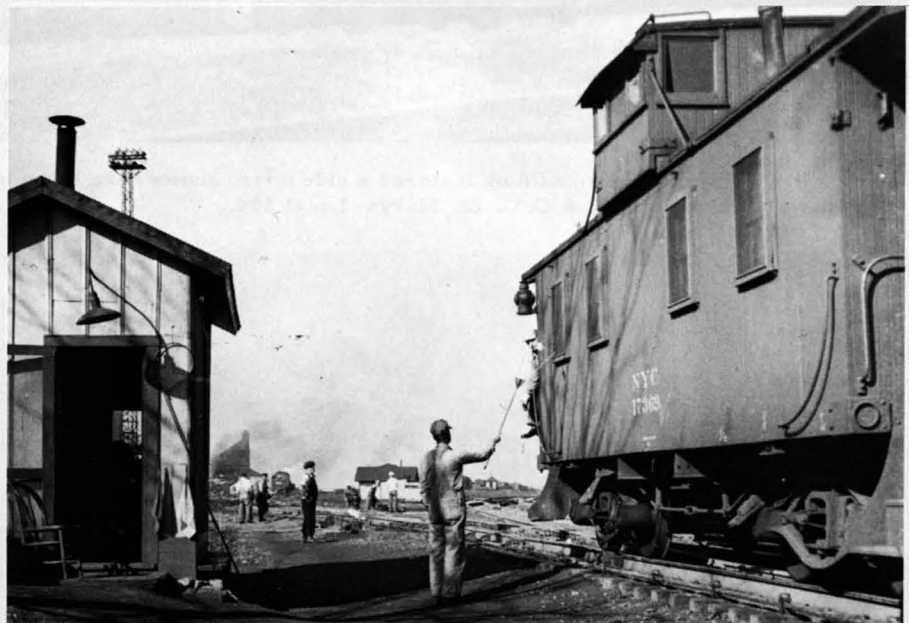
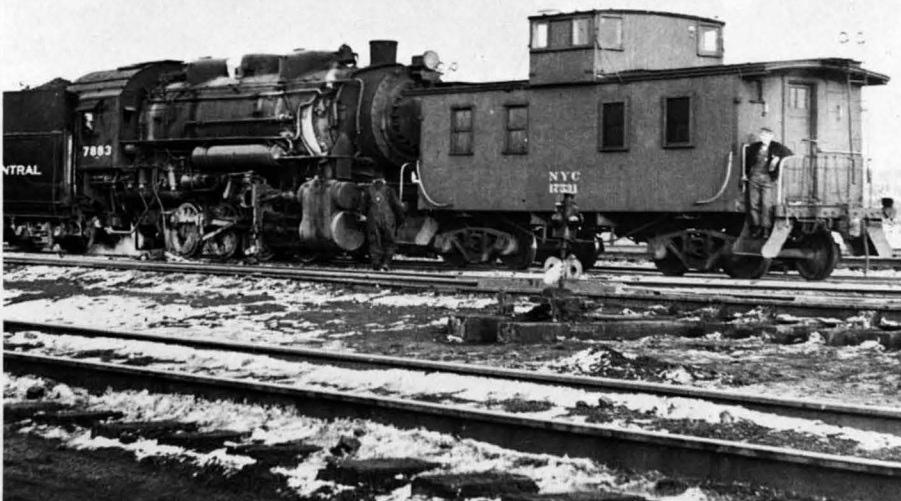
Orders are hooped up to the crew of Big Four caboose #17369 as its freight train passes Sandusky St. in Bellefontaine, Ohio on June 26, 1948. Caboose is equipped with window screens and a tin sun shade above cupola side windows. Coaling tower can be seen in the distance.

N. Y. C. #7883, Class U-3h 0-8-0 switcher works the freight yard at Bellefontaine, Ohio in July, 1948. The locomotive was built by Alco's Brooks Works in 1926, the Big Four caboose #17531 was constructed by Beech Grove shops (Indiana) in 1913.

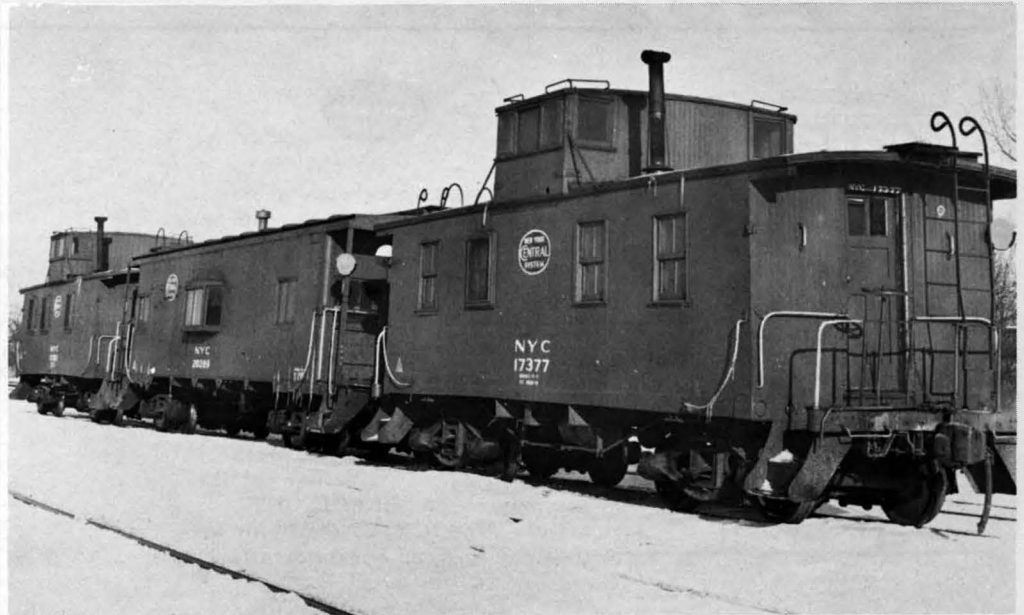
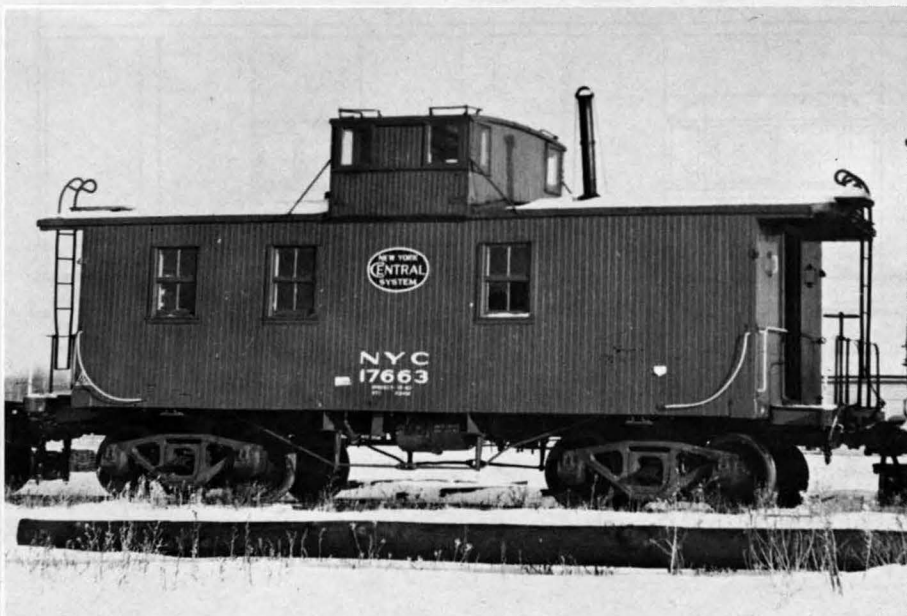
Sandwiched between two Big Four cabooses, an N. Y. C. steel bay-window caboose awaits an assignment at Bellefontaine, Ohio, in January, 1963. The steel caboose like its two 50 year old companions, is painted box car red.
Si Herring Photo

Caboose #17663 appears to be in good shape in this photo taken in January, 1963. Note the fancy "curl" on the ladder handrails which was always a distinct spotting feature of the Big Four cabooses. One of the side windows has been "planked over".
Si Herring Photo
