CABOOSE The CLASSICS

Part Two

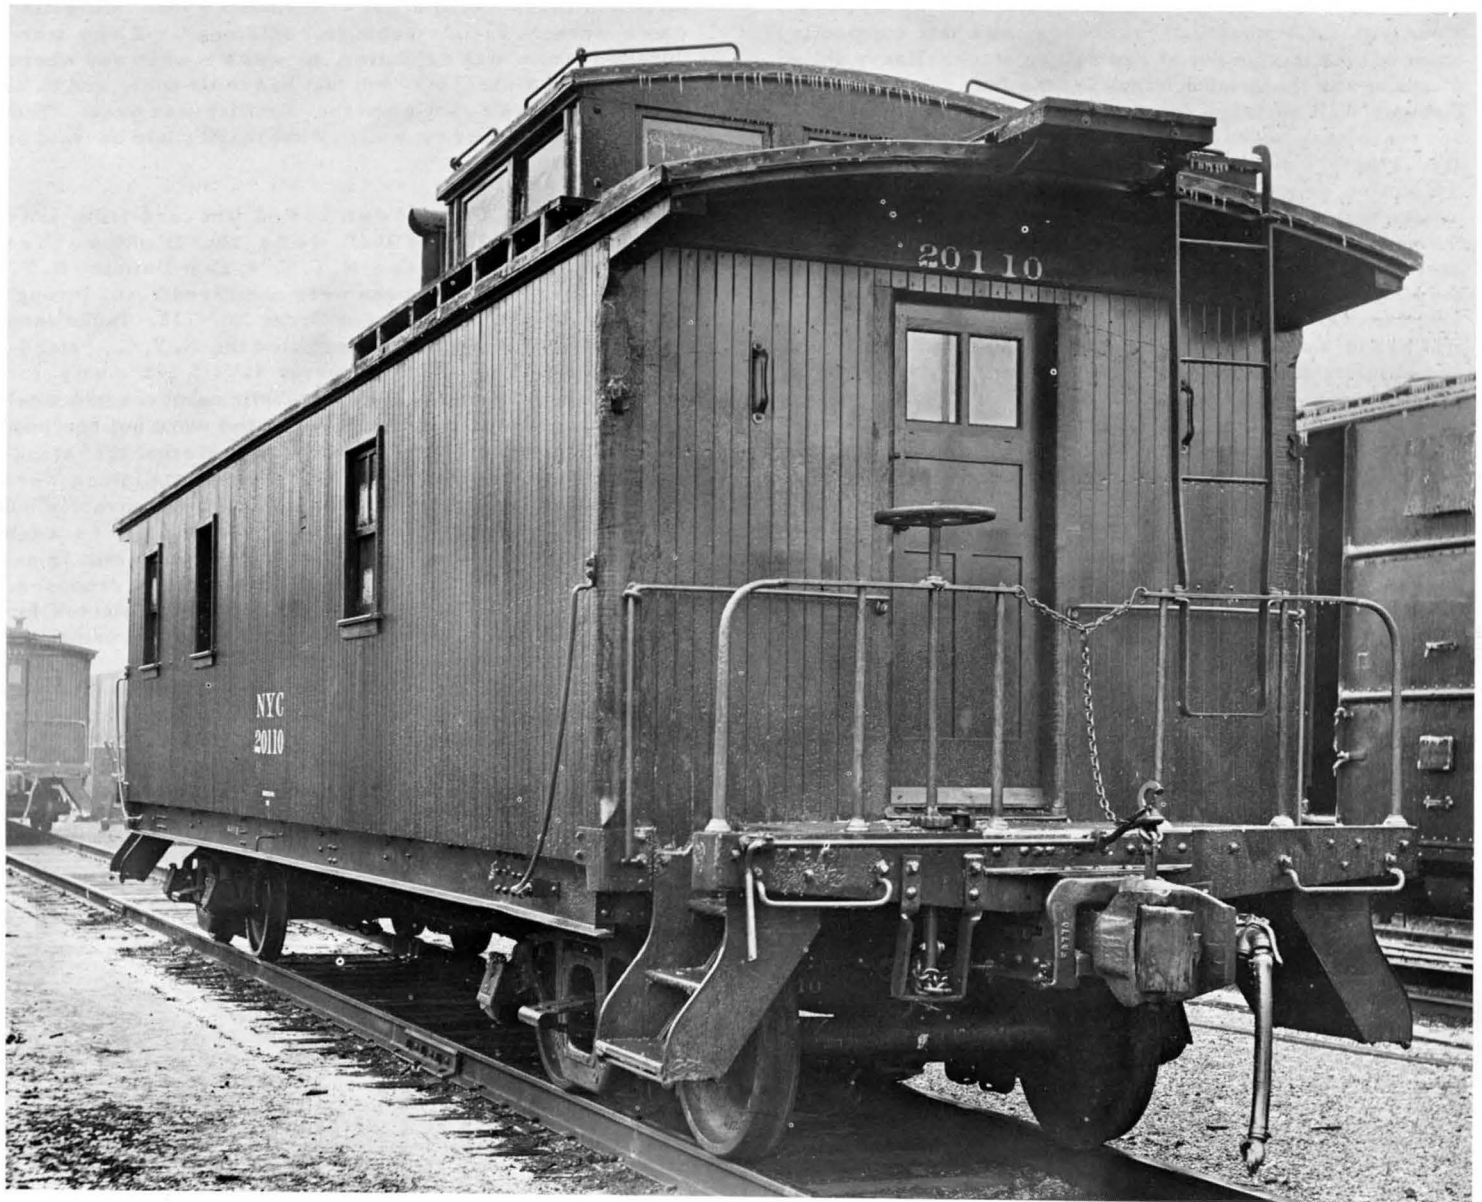
Caboose No. 20110 stands for its "builders" portrait at East Buffalo, N. Y. where it was rebuilt in 1944 from a 1910 era box car. Notice how closely this series of cars follows the general lines of the "standard" N. Y. C. caboose shown in "The Caboose Classics (Part One)". There were 50 cars in this series; No. 20100 thru 20149. Most of these, (45) were painted box car red as shown above. Five were painted Vermillion and Gray to match N. Y. C.'s "Pacemaker" high speed freight service equipment. All were built as lot order No. 732, their overall weight was 30 tons. W. D. Edson Collection

In 1944, fifty 36' wooden bodied box cars from Lots 234, 236, 240, 247, and 262B were rebuilt into rather handsome cabooses by the N. Y. C.'s East Buffalo, N. Y. Shops. The "new" cabooses were numbered 20100 through 20149 and were assigned Lot Order No. 732. In outward appearance, the cabooses resembled the N. Y. C. "standard" which was 30' - 1 5/8" versus 35' - 5 5/8" long for the rebuilds. Secondly, all of rebuilt cabooses had steel underbody frames and siderails and were not equipped with the truss rod type of carbody supports that the "standard" caboose was equipped with. These rebuildings were not "quickie" projects and unlike the earlier converted box cars, these were built to serve for years. Quite a few lasted into the 1960's, with at least 24 of them still in existence as late as 1962. In 1946, five of these cabooses, 20112, 20117, 20129, 20132 and 20133, were selected for service on N. Y. C.'s newly inaugurated "Pacemaker" freight train service. In order to provide a smooth "modern" appearance, the caboose bodies were sheathed with plywood and painted to match the "Pacemaker" box cars (see July 1974 "Headlight", Page 13). Besides the Vermillion and Gray paint job, these cars were equipped with AB-1-B air brakes, signal lines and Waughmat twin cushion draft gear. The trucks were high speed Barber-Bettendorf 4 1/4" x 8".

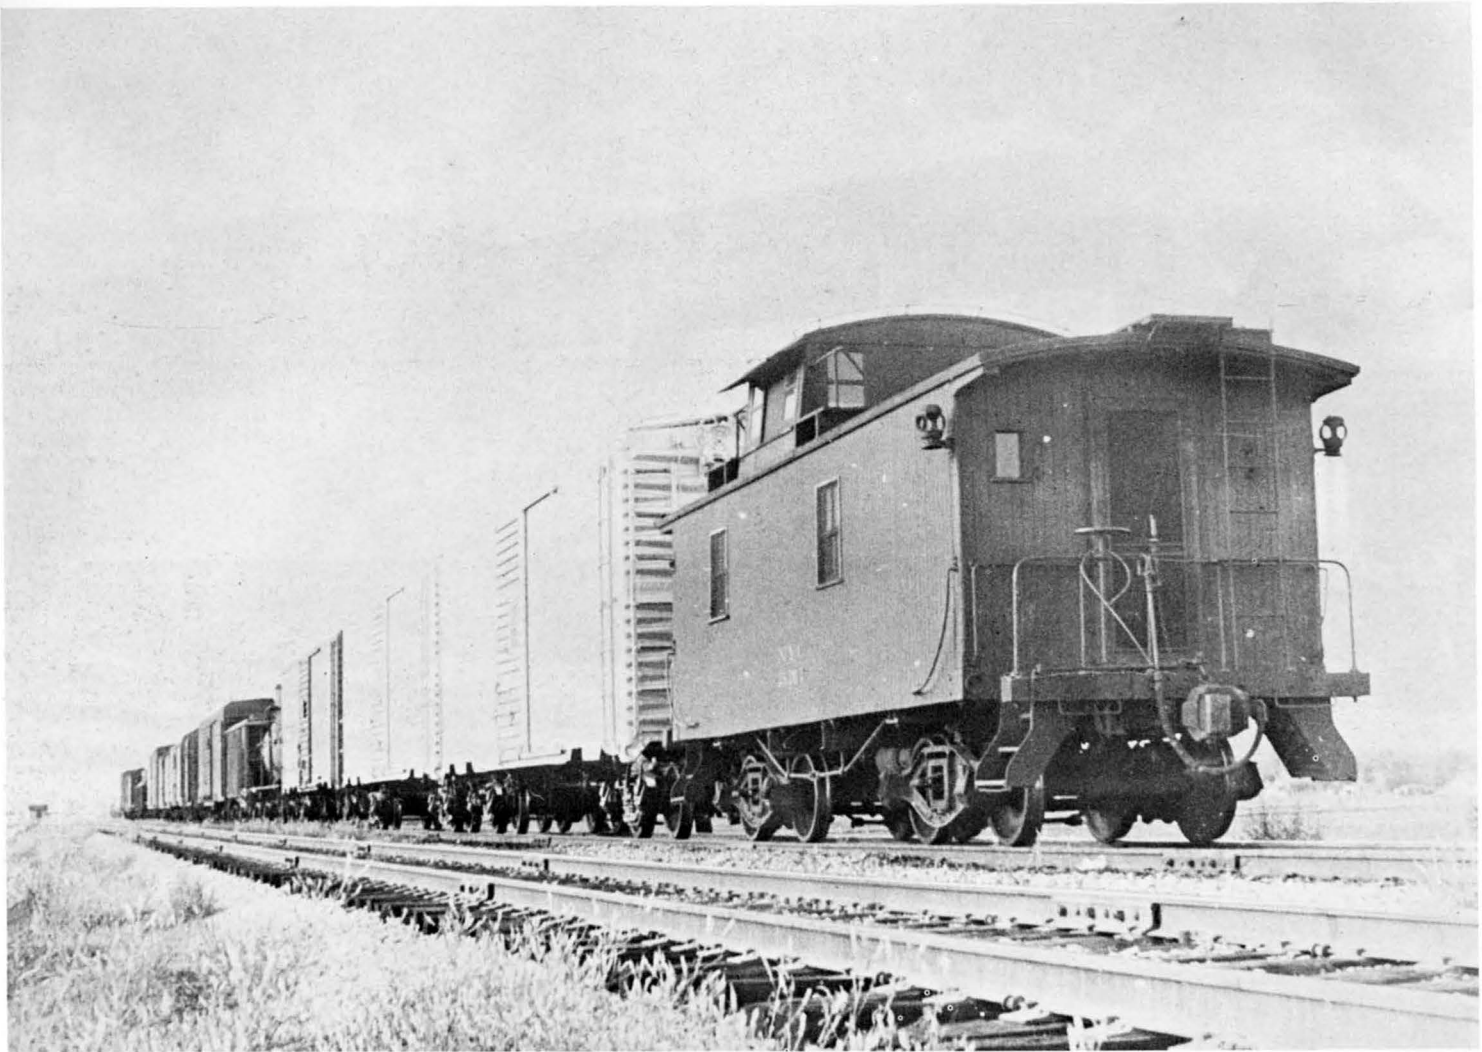
Although the quality of this photograph leaves something to be desired, the subject matter makes it well worth reproduction. This rare photo shows N. Y. C. caboose No. 18161. It was originally a L. S. & M. S. caboose as is still equipped with it's original cupola. Later rebuilding resulted in the short "gun turret" type cupola shown on the facing page.

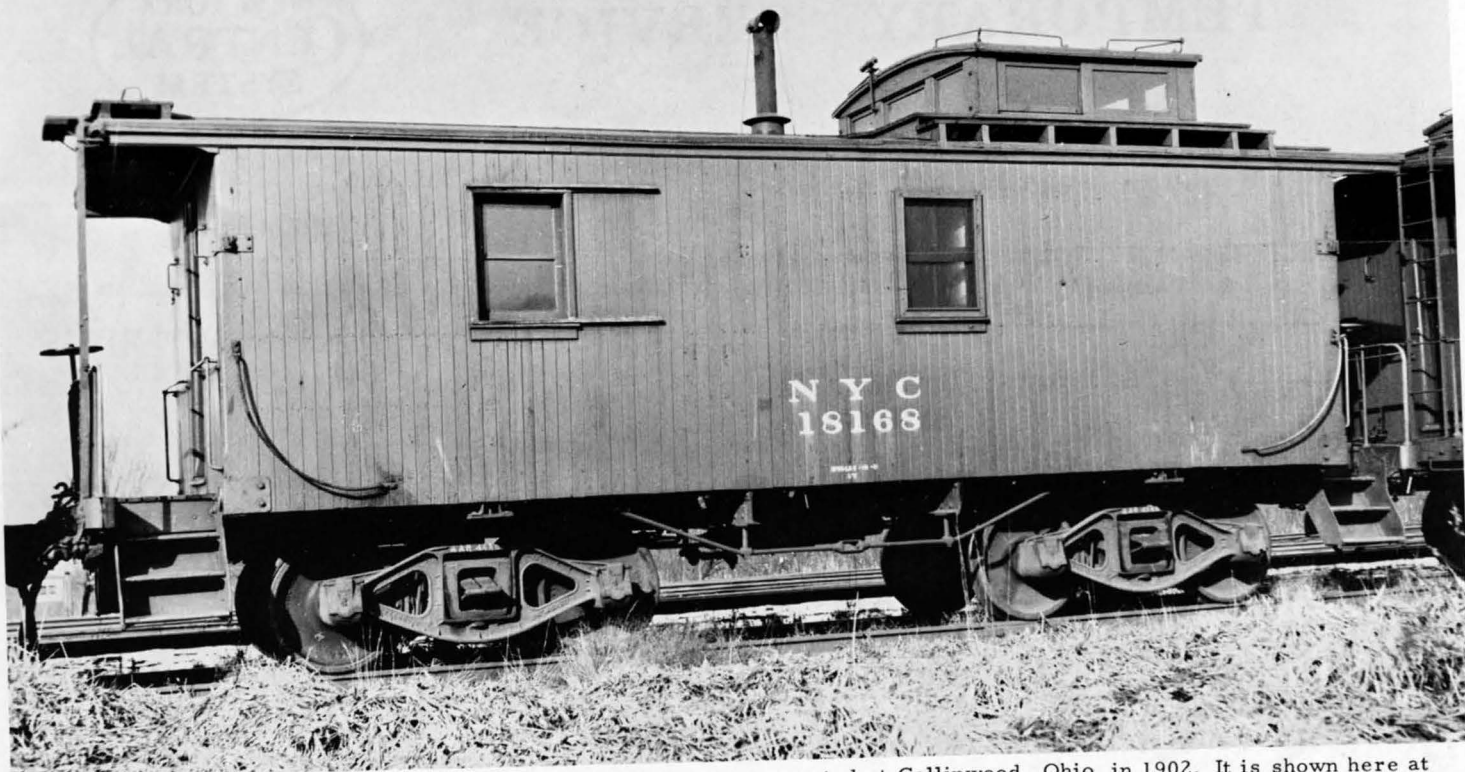
N. Y. C. (Ex-L. S. & M. S.) caboose No. 18168 was originally constructed at Collinwood, Ohio in 1902. It is shown here at Stoneboro, Pennsylvania on January 12, 1952. Paul W. Prescott Collection

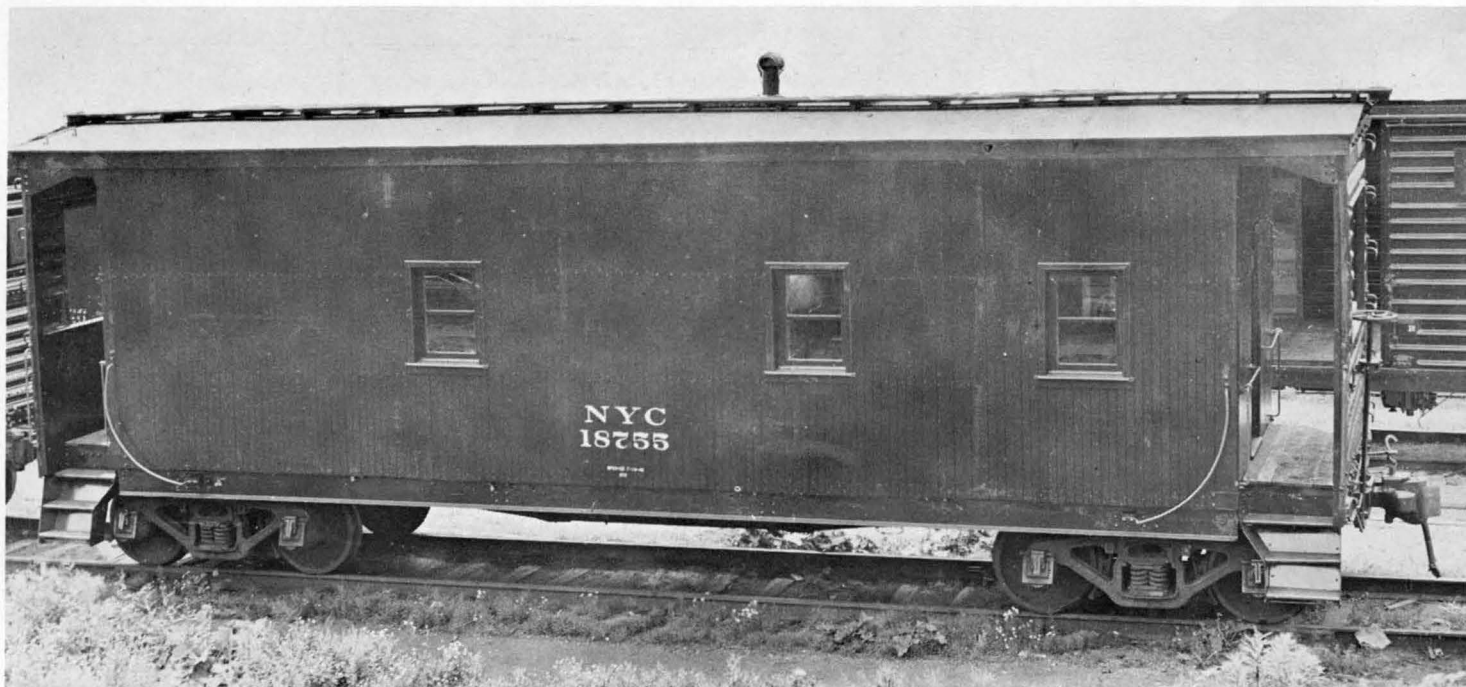
Wartime caboose #18755 shows an attempt to make the end platform steps safer by giving them more "slant". Note smooth roof without rib reinforcements showing.

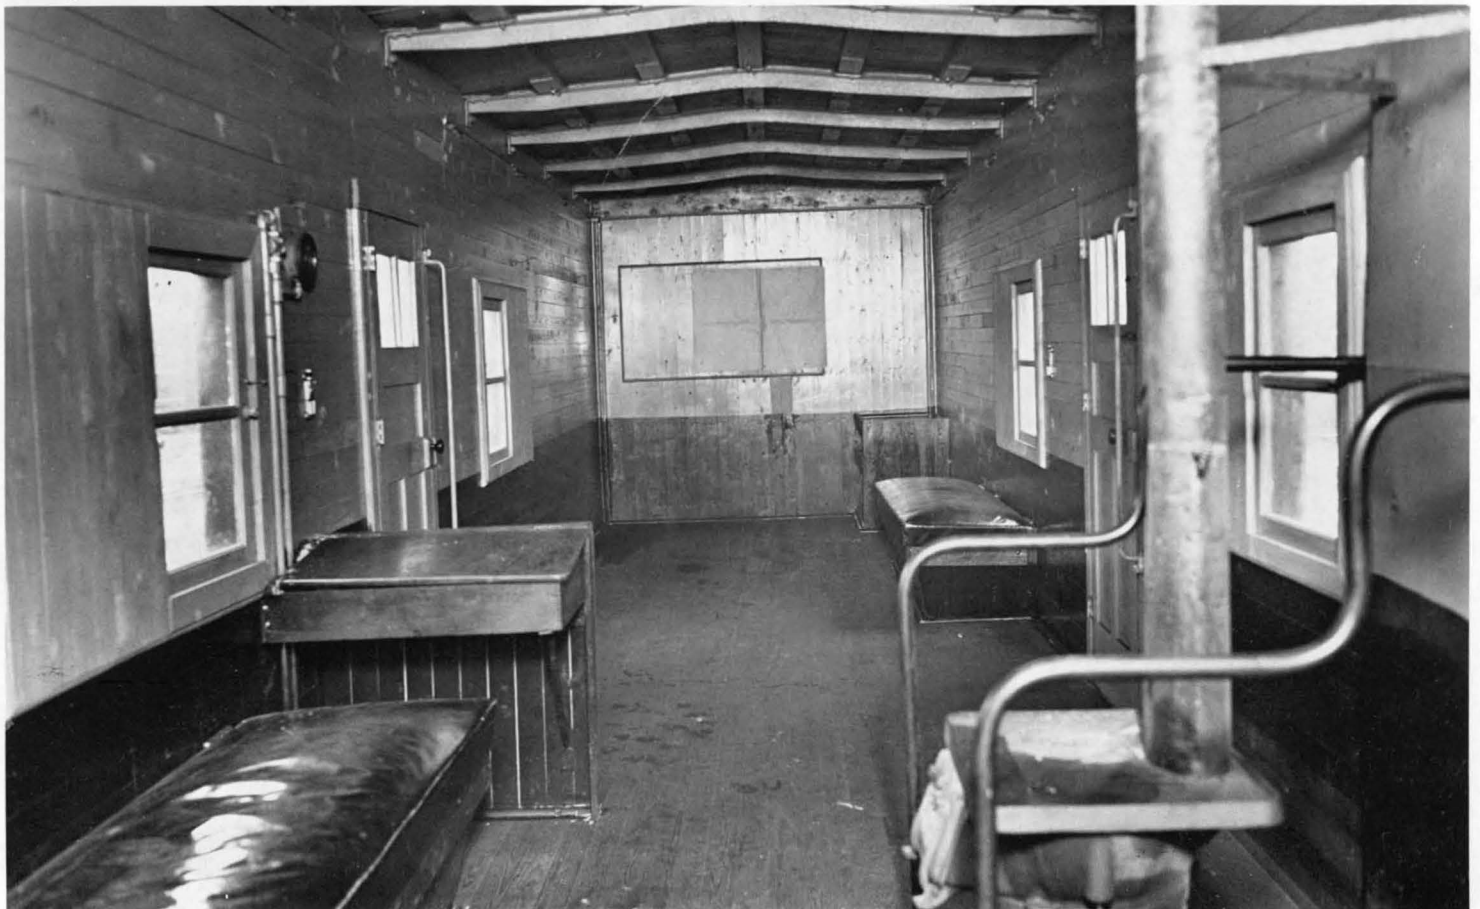
Interior shot of #18671 reveals conductor's desk, coal stove and bunks. This could hardly be considered cozy.

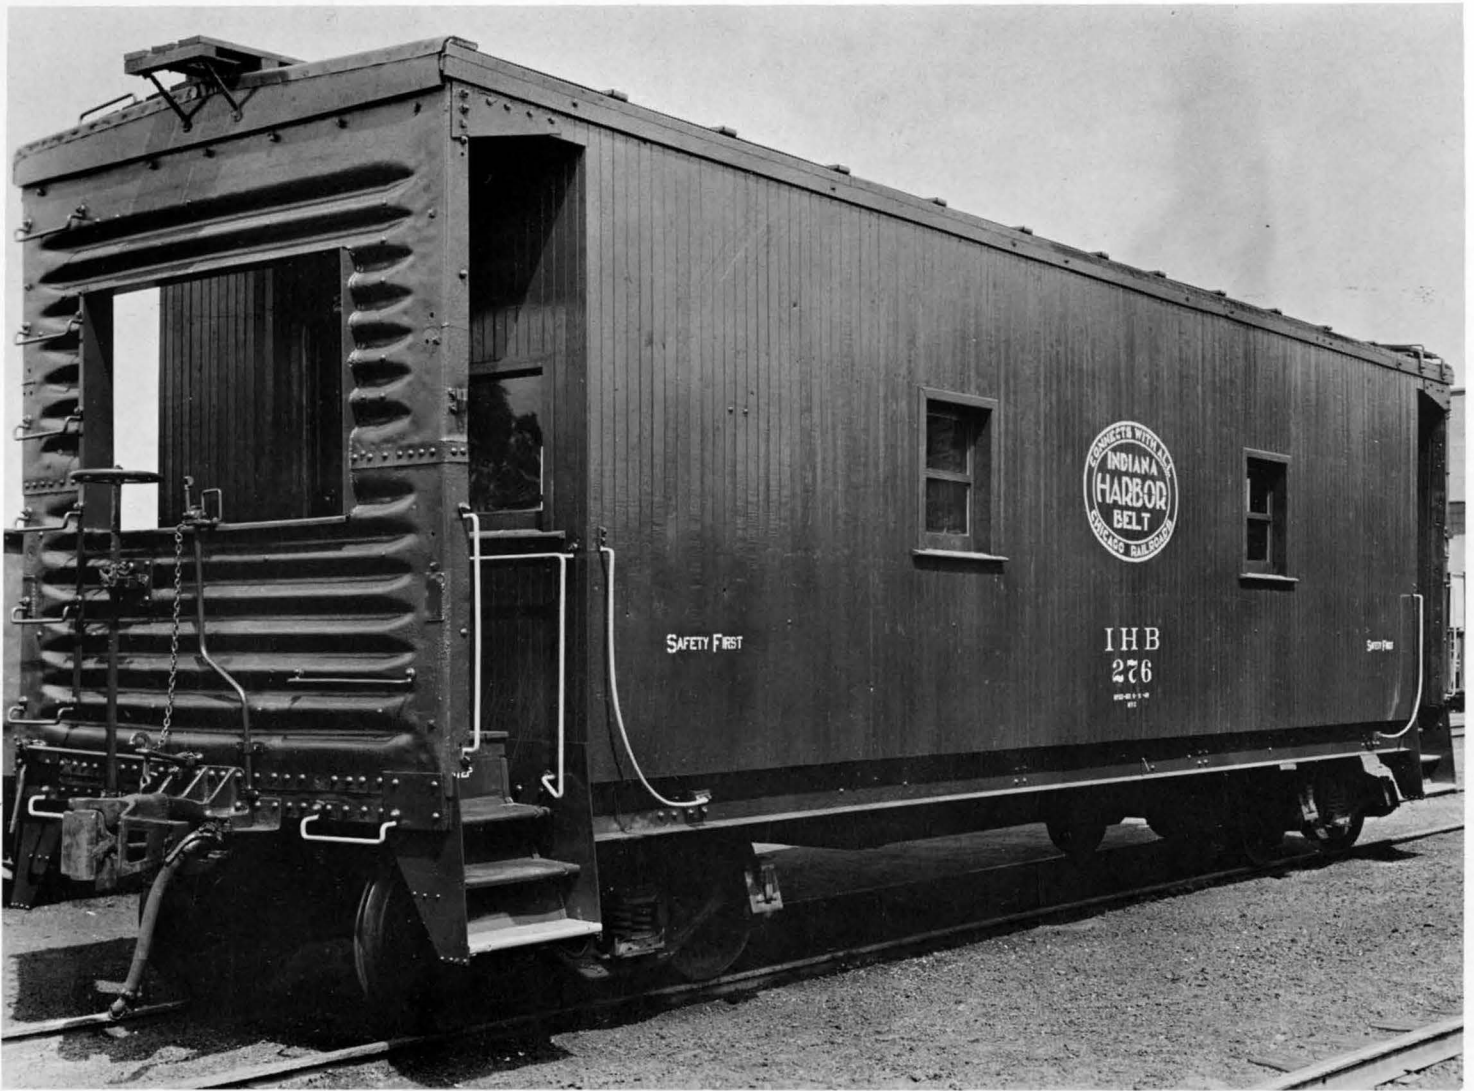
Official "Re-Builders" photo of I. H. B. temporary caboose #276. Box car ancestry is quite evident in this view.

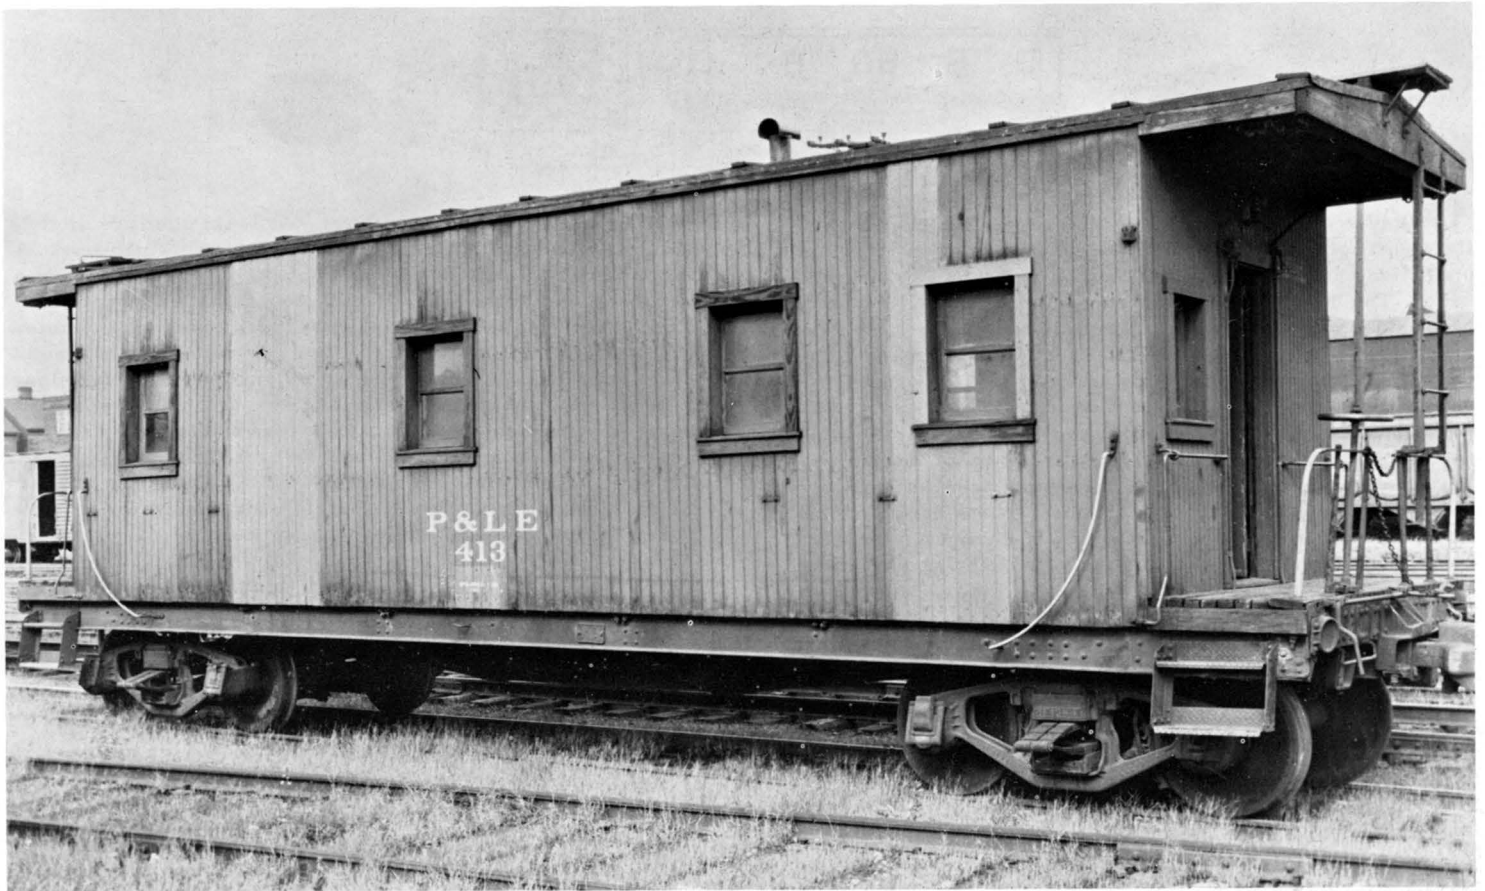
P. & L. E. #413 illustrates one type of wartime caboose used by the railroad. This box car conversion featured end platforms and stirrup type steps.

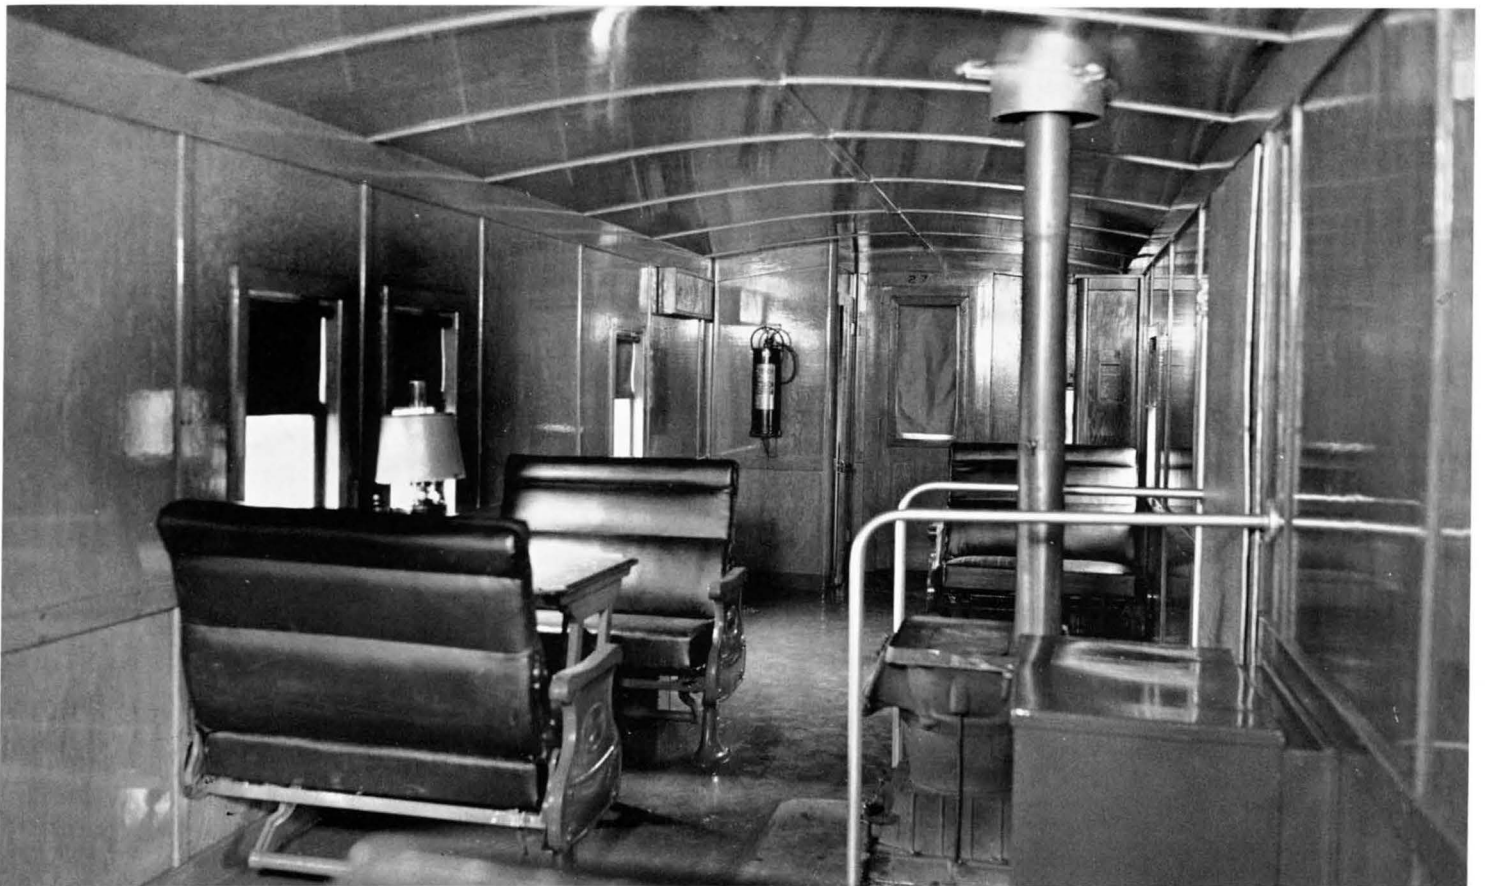
Interior of rider car No. 2708 resembles slightly a passenger car of the 1860-1870 period. The accommodations certainly seem superior to those belonging to the temporary cabooses shown on preceding pages.

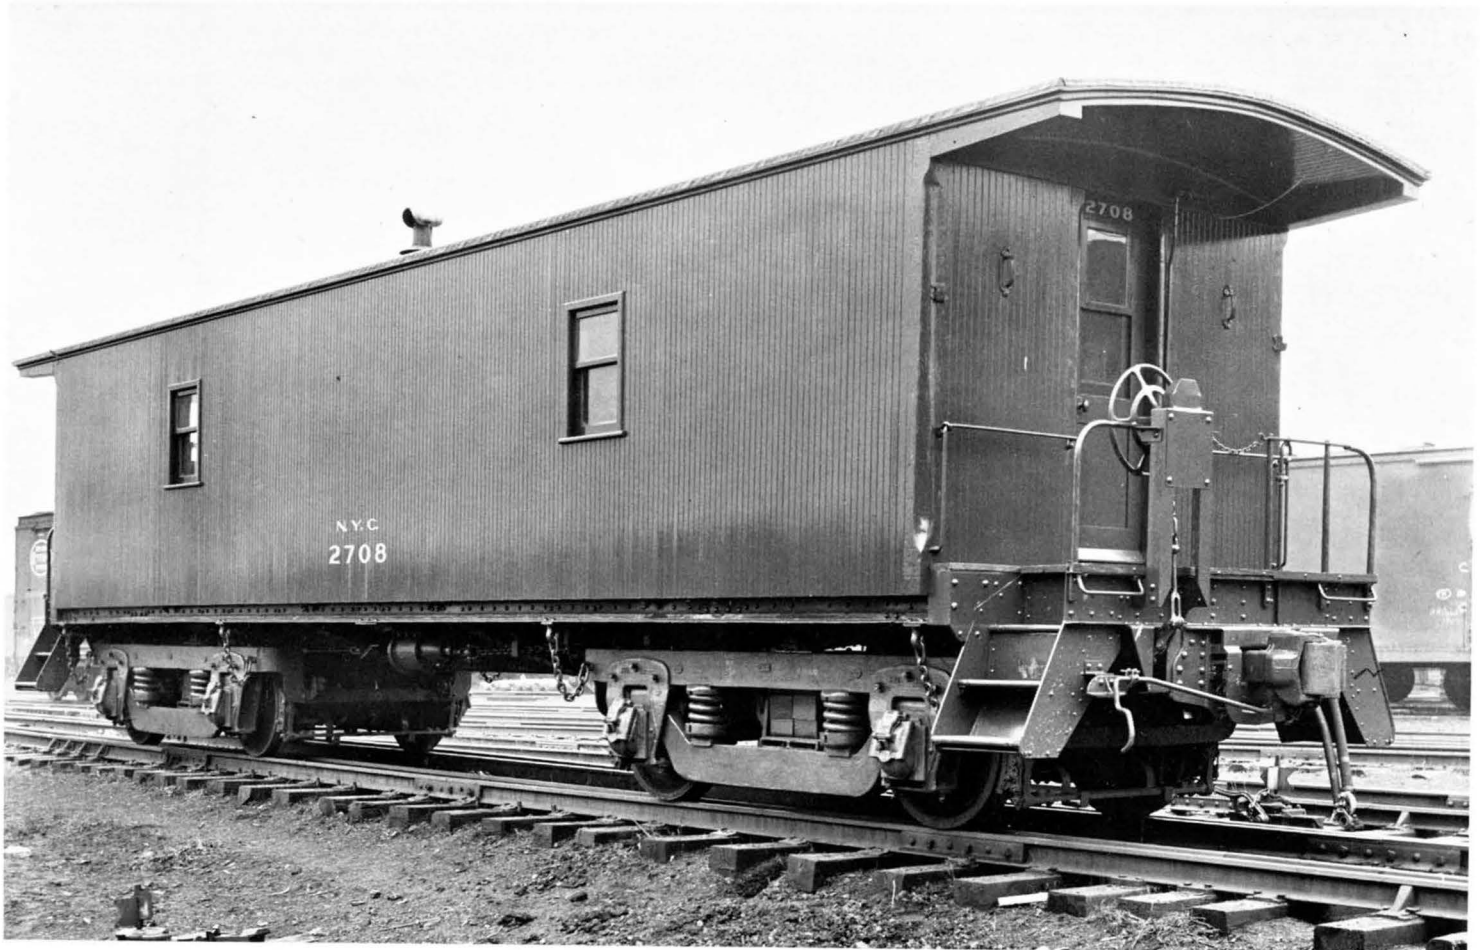
N. Y. C. rider car No. 2708, lot order No. 2168 was built in 1943. There were 20 cars in this series 2708 - 2727. This side of the car shows two windows, there were four windows on the other side as per the diagram at the top of the opposite page.

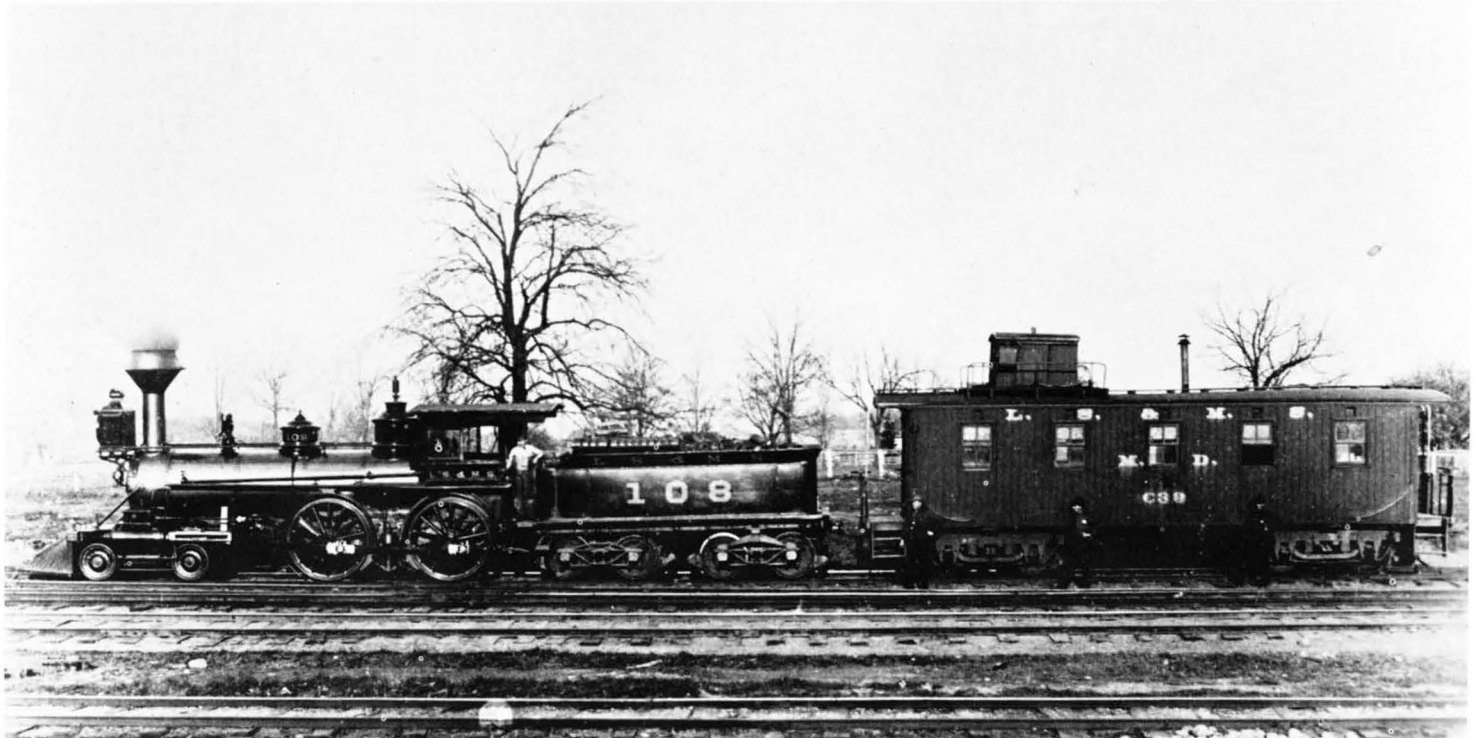
L. S. & M. S. caboose C-39 seems to almost dwarf 4-4-0 No. 108 in this early photo. The locomotive was originally named "Appachee" when it was built in 1869 by Mason Machine Co. It was retired between 1893-99. The caboose, unless it was destroyed by fire or train wreck probably survived longer. Note elaborate outside equalized trucks under the C-39.

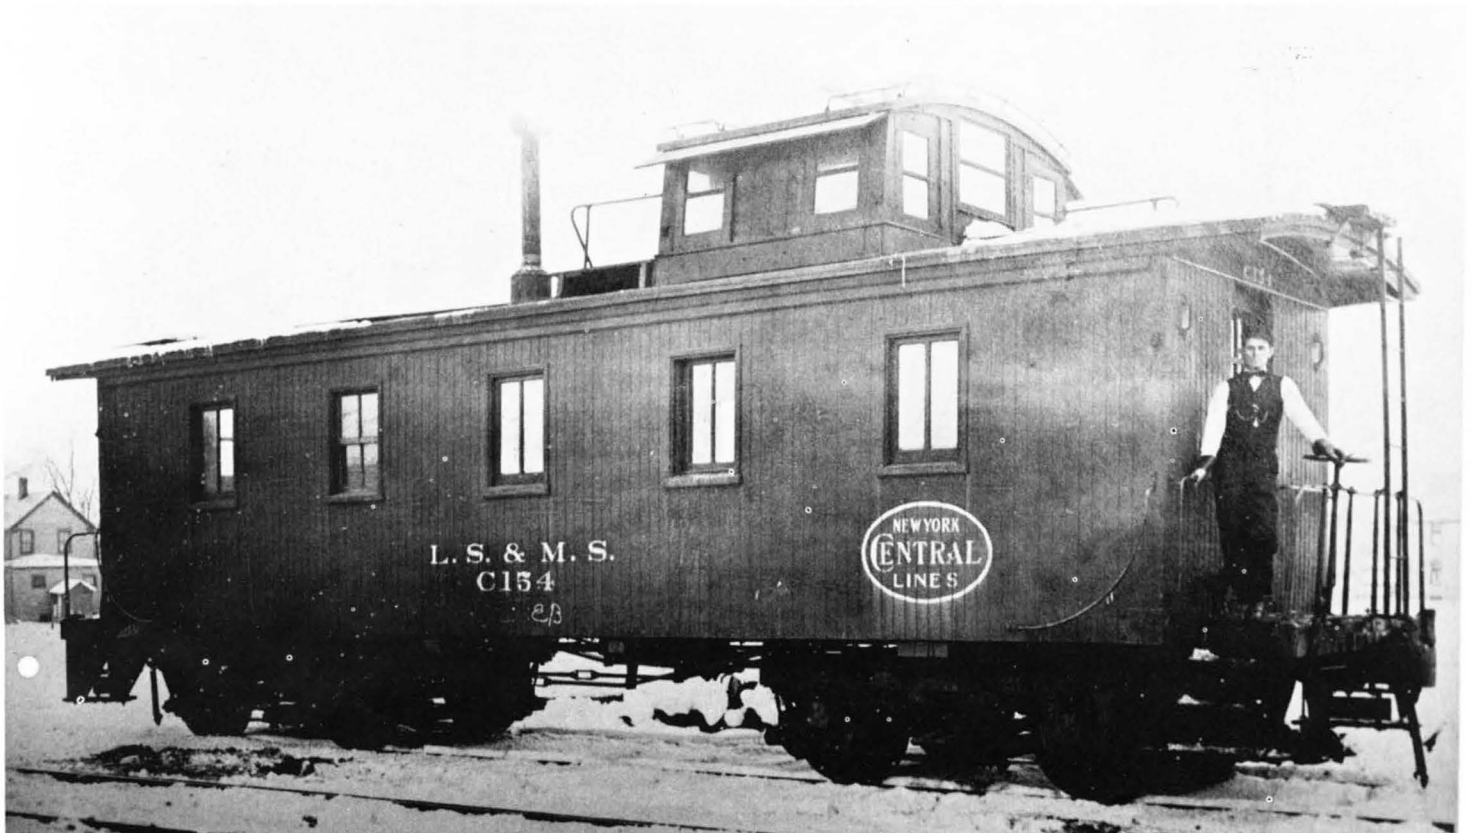
L. S. & M. S. crew member seems very proud of his caboose, C-154 which is equipped with five side windows, a large cupola, and some very unusual looking trucks with the usual leaf springs.

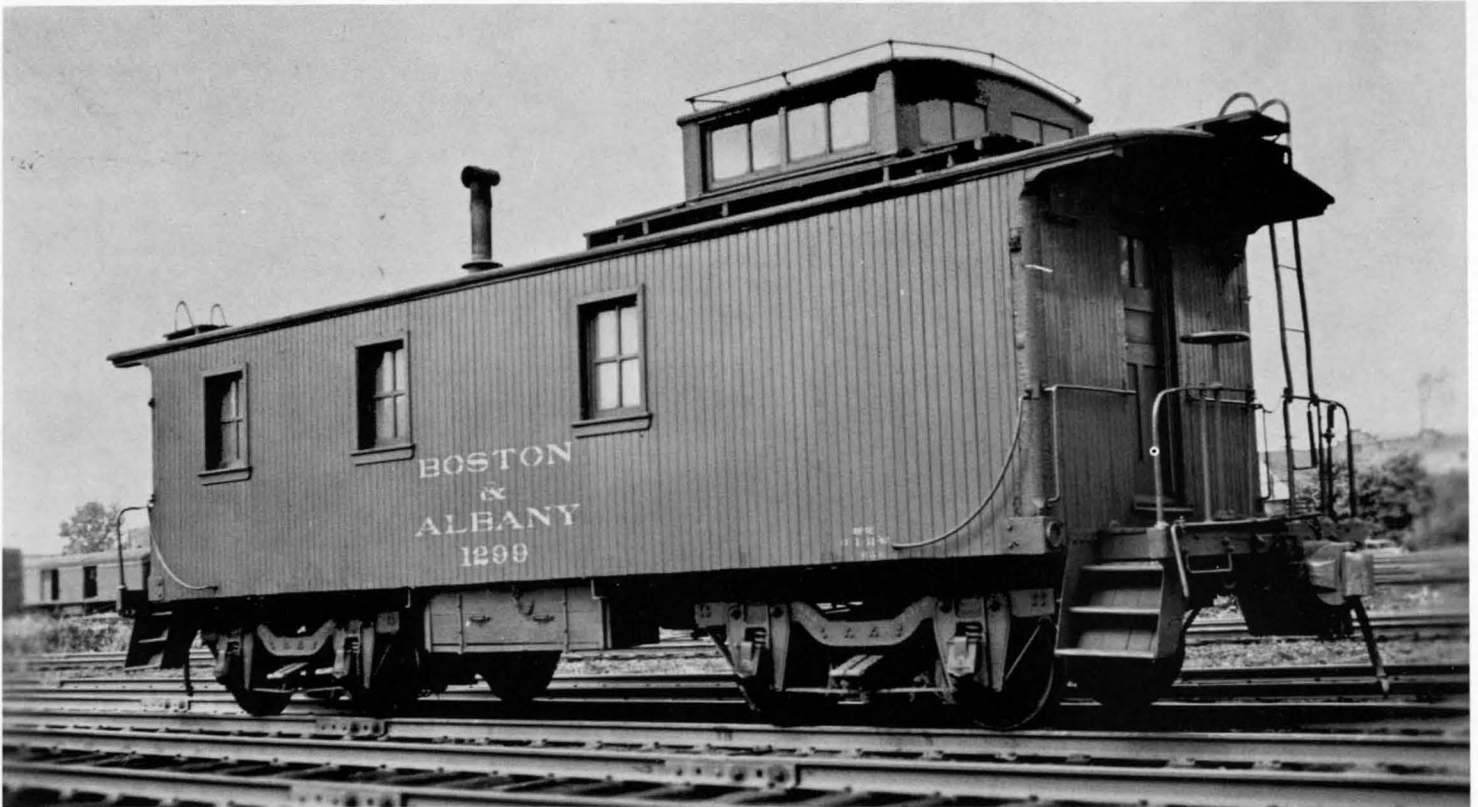
B. & A. caboose No. 1299 at first glance resembles the "standard" N. Y. C. caboose covered earlier, but the cupola appears to be taller, the steps slightly different, and with the addition of an underframe tool box and large wheeled unusual trucks these cabooses have an appearance all their own. There were 80 cabooses in this series which were originally numbered 1117 - 1299 and were renumbered 17000 - 17081 in 1952. This photo was taken at Rensselaer, N. Y. on June 2, 1940.
Colonel C. B. McCoid Collection

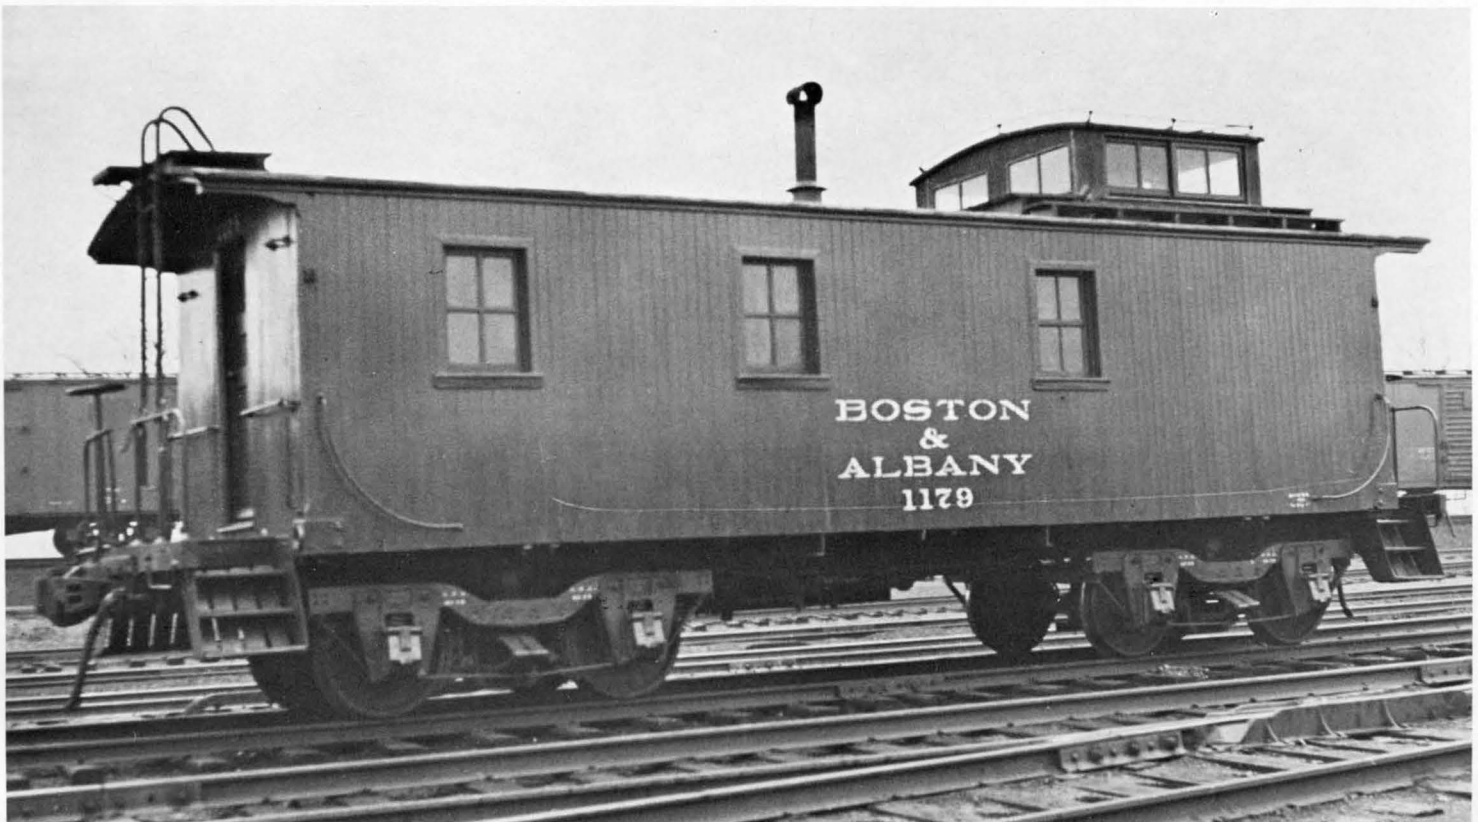
Boston & Albany caboose No. 1179 is shown here at East Pittsfield, Mass. on February 21, 1937. Note the open slats which provide the backstop on the caboose steps.
George E. Votava Collection

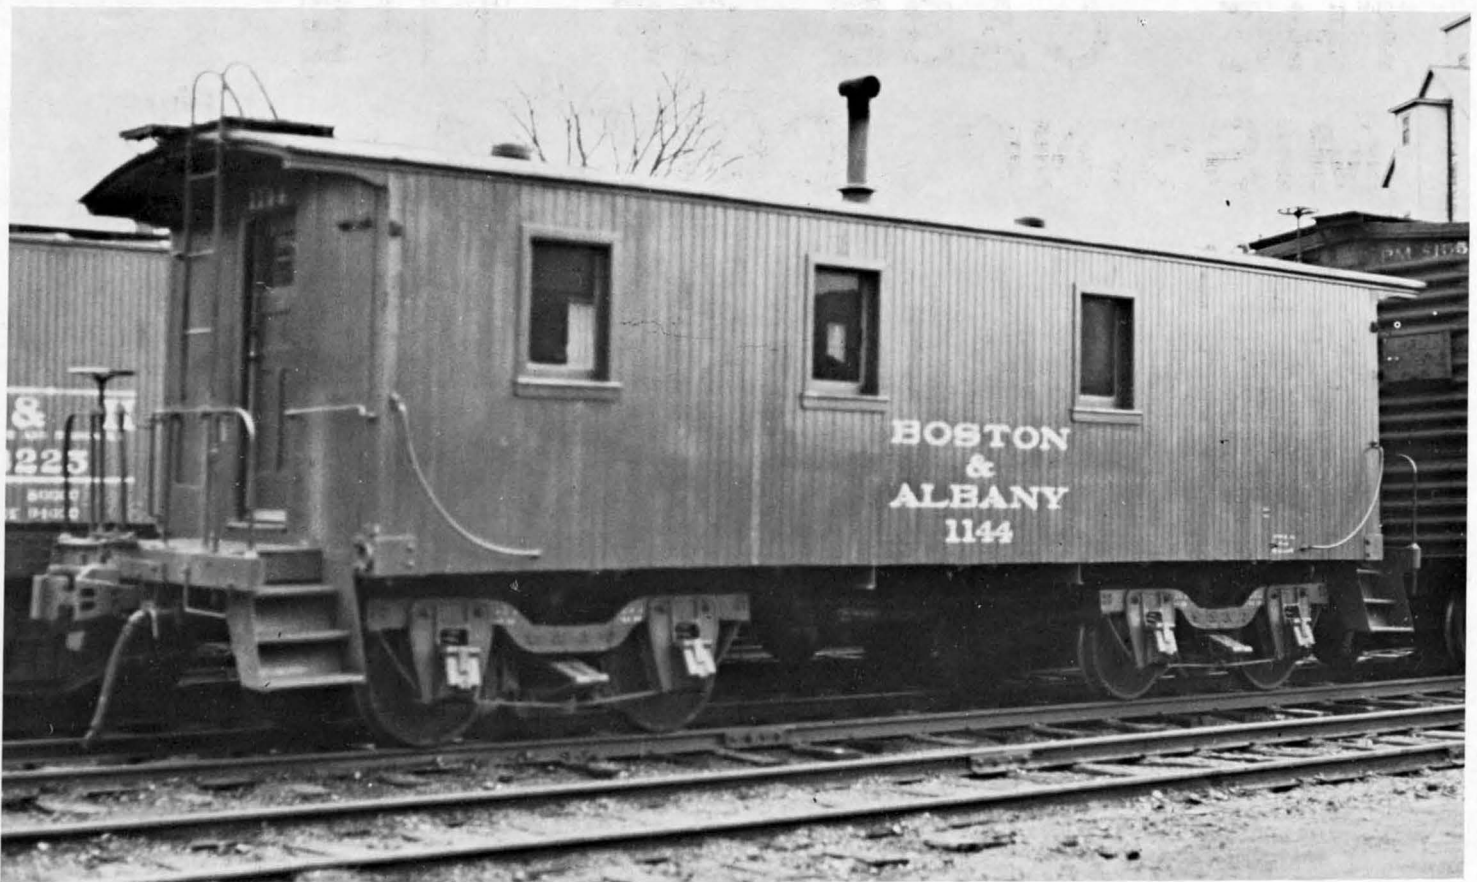
Boston & Albany caboose No. 1144 stands on a siding at North Adams, Mass. The date is February 22, 1937. This caboose was originally constructed in the B. & A. shops in 1924. George E. Votava Collection

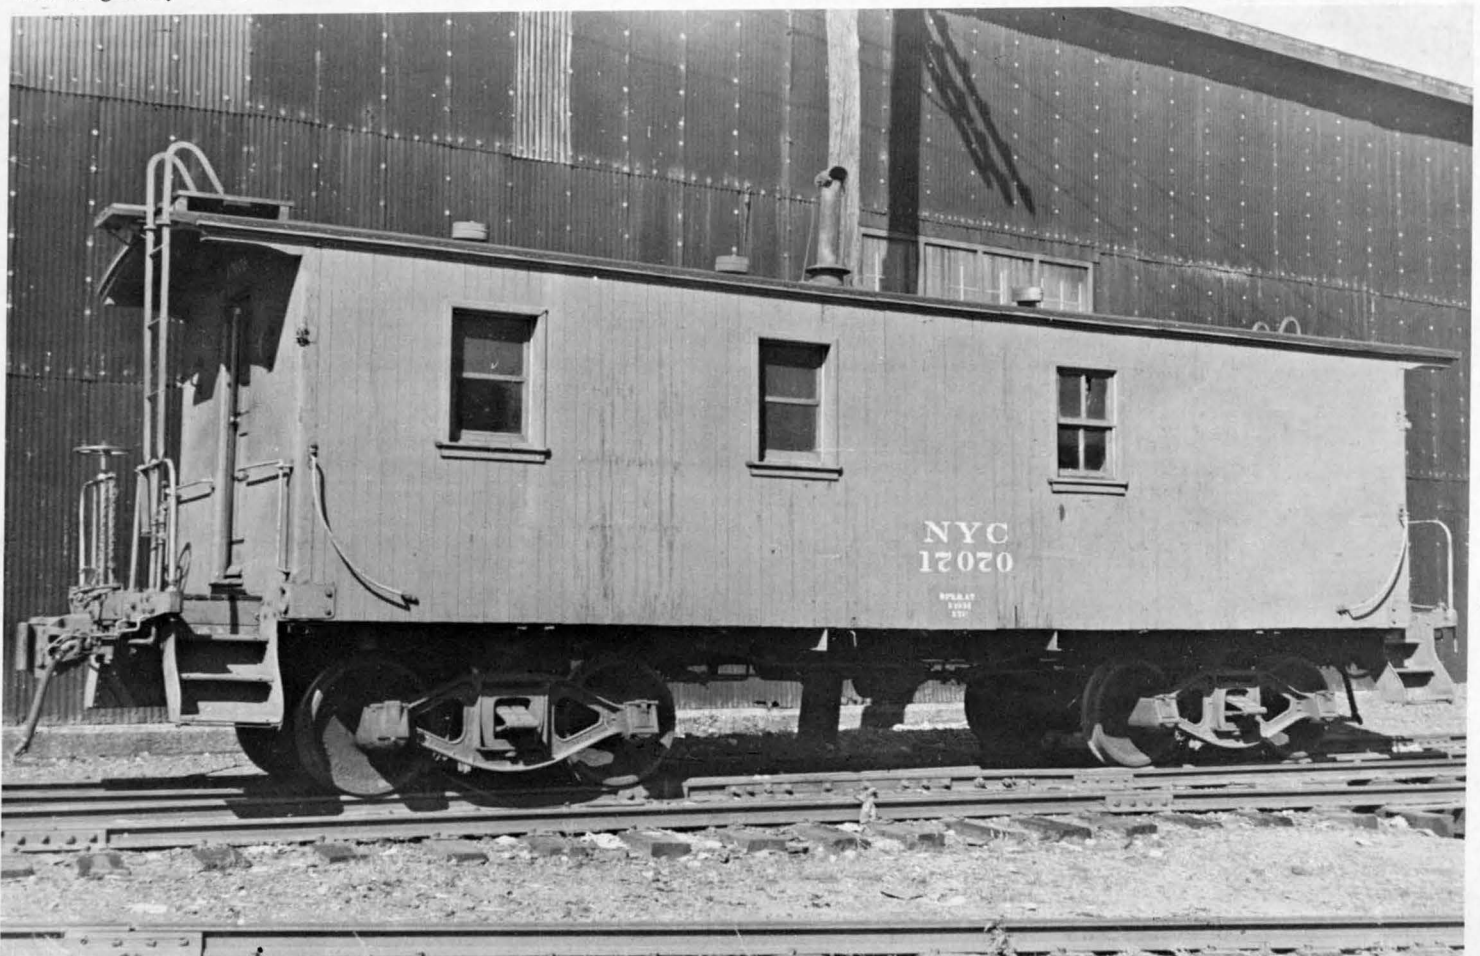
N.Y.C. caboose No. 17070 was originally Boston & Albany No. 1289 before its renumbering in 1952. Notice the extra roof vent stacks added when the cupola was removed and that the unusual B. & A. caboose trucks have been replaced by the N.Y.C. "T" section caboose truck. The date is September 12, 1954, the place is Framingham, Mass. George E. Votava Collection

As freight cars grew taller and wider over the years, the New York Central System, along with many other railroads, discovered that in most cases the cupola was worse than useless. Beside the fact that the crew was now unable to see over the roofs of many of the cars that they had to handle, the extra windows of the cupolas were proving useful only for giving vandals another aiming point for throwing rocks and stones and giving the N. Y. C. increasing maintenance costs for their wooden caboose fleet. As a result of this, as cabooses required shopping many cupola windows were simply boarded over and then painted. If the cupola itself was in bad shape and in need of heavy repairs, it was often removed with the resulting area boarded over to match the original roof contour. The resulting rebuilds were usually assigned to yard or transfer service. The accompanying photos prove that this type of surgery was not confined to one type of caboose on the New York Central System, and will help to illustrate, "The Case Of The Missing Cupolas".
