## HIGH SPEED WATER SCOOP AND LOCOMOTIVE TENDER DESIGN FOR THE NEW YORK CENTRAL SYSTEM

Carl F. Kantola Assistant Engineer, Equipment Engineering Department

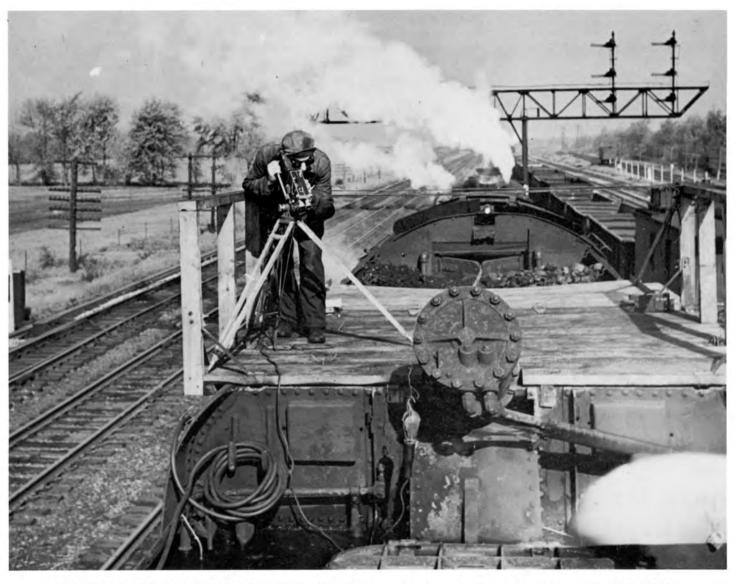
Carl Kantola with movie camera on tender platform preparing for a test run scooping water at 80 M.P.H.

Since I had a general idea of the source of the trouble, I was assigned to investigate the complaint and develop a solution. In order to demonstrate just what was taking place when water was scooped, a test train consisting of class J-Ie Hudson #5328 with 14,000 gallon, 28 ton tender, dynamometer car X-8006, and two coaches was assembled. Mr. Fred Beach, our company photographer and myself were to ride on top of the tender tank with a movie camera directed at the water filling hole to record what happened while scooping water. The tests were run on the Rome, N.Y, track pans.

The test run turned out to be a very hazardous trip into a 20 mph head wind at 80 mph track speed. As we expected, the force of the water in the tank bent the filling hole cover at each side of the centrally-located latch. The water rushed out, flooding the tank top and cascading over both sides and the rear of the tender. Although we were thoroughly drenched and were nearly washed overboard, we managed to hang on and to also save the movie camera.

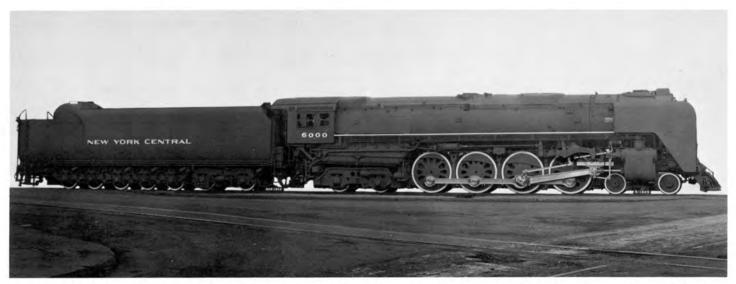
Class S1a locomotive #6000, Niagara type, with 14-wheel PT tender. Tender equipped with high speed water scoop, auxiliary surge tank and six overflow vent pipes on each side. Carl F. Kantola

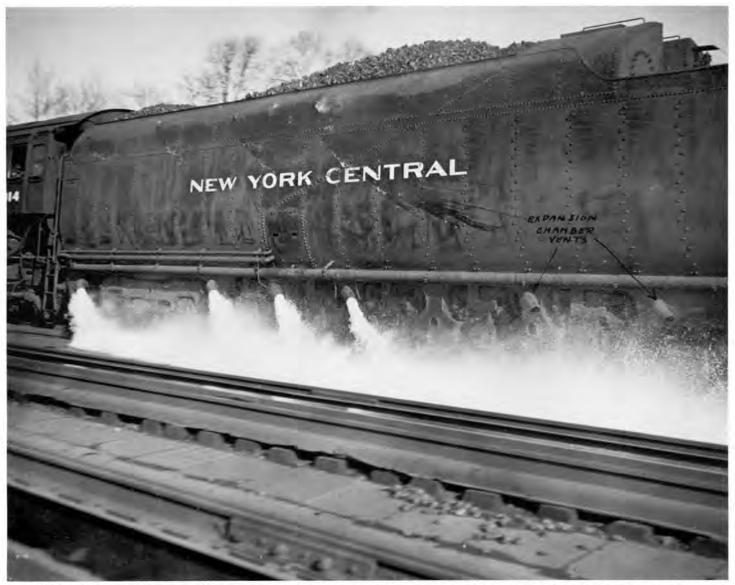
This is a close-up of a locomotive PT tender scooping water. This tender is equipped with overflow control and excess water is discharged from four of the forward end overflow-vent pipes each side, indicating that interior construction of tender permits scooped water to be carried to the extreme forward end of tender instead of cresting in the rear portion of tender. Note the paved gutters between tracks onto which the overflow water is directed so that no damage is caused by same. 6,000 gallons in 17 seconds creating the effect of jet propulsion, speed 85 M.P.H.

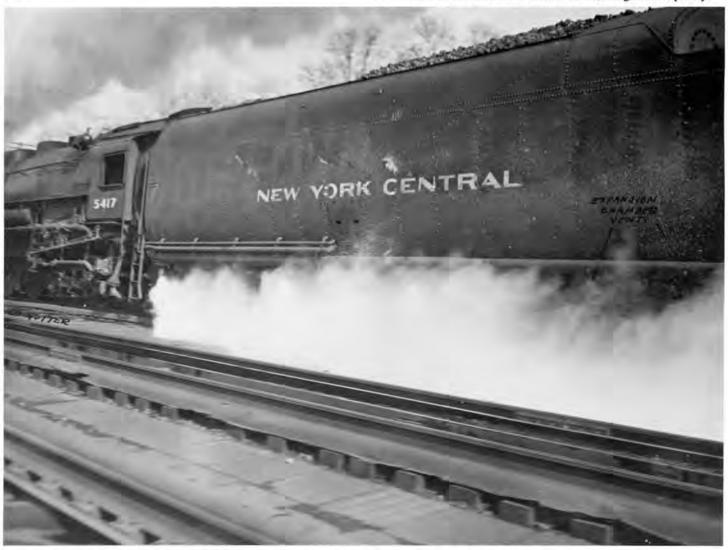
This is a close-up of a locomotive tender scooping water. This tender is equipped with overflow control and excess water is discharging from overflow vent pipes throughout the length of tender except the pipe which vents from the top portion of expansion chamber, indicating that the tender has filled with water but has not yet surged up to the highest part of the expansion chamber. Note the absence of any overflow from top.

The drawing dated June 25, 1943 clearly illustrates the features of a tender tank equipped with overflow control. The water scoop delivery pipe inside the tank extends above the water line of a full tender so as not to drain water downward. The upper end of this pipe is turned forward to force the flow of water to the front of the tank. A divider is located directly ahead of the pipe to divert the flow to the compartments on each side of the coal space. Four vent pipes are located at the top of each side compartment to allow escape of trapped air and for overflow of water when the tender is filled. These pipes with a reverse bend extend downward below the tank and are directed to drain onto the paved gutter. Syphon breakers are provided at the reverse bends to prevent loss of water through syphoning action. Two expansion reservoirs are constructed to the rear of the coal space on top of the tank. The surge of water while scooping rises up into these reservoirs and then levels off the water supply after the scoop is lifted. Two air vent and overflow pipes are provided on each side of these tanks. Two additional air vent and overflow pipes are also provided, one at each corner of the rear tank top. A trap door hinged to the bottom edge of the filling hole funnel is provided to act as a check valve. A counter-weighted arm on this door holds it in the closed position, thus providing a seal against overflow through the filling hole cover. When taking water from an overhead spout in the conventional manner, the weight of water on this trap door will open it.

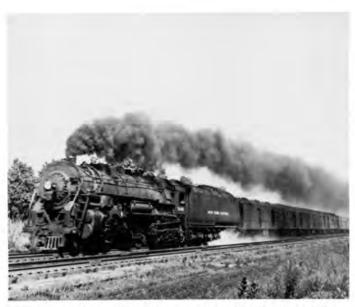
N.Y.C. Hudson 5410 takes on water Westbound at the Corvnna, Indiana track pans in 1946. Note working overflow vents on the PT tank. — Bob Lorenz Collection

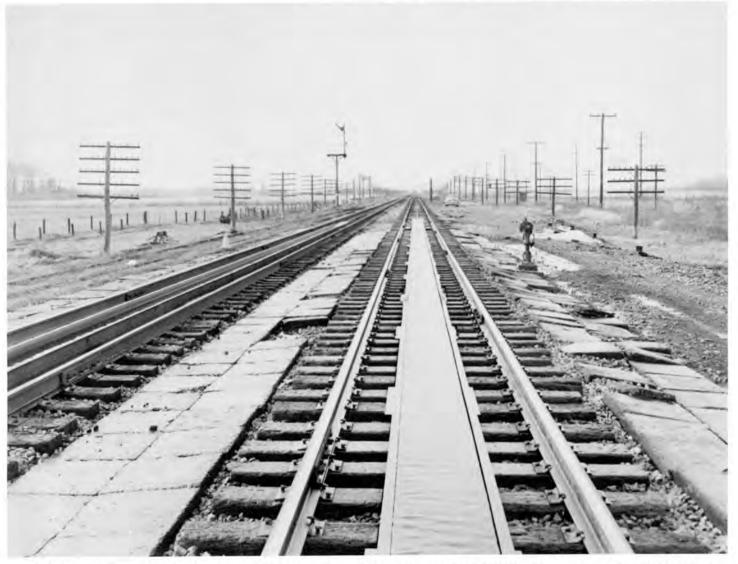
Looking west towards end of Lydick, Indiana track pans, Track #1, November 20, 1945. Purple indicator light for end of pan at right. NYCSHS

It was found during tests that some time was lost in operating the scoop due to the distance between the operating valve and cylinder on the larger tenders. Therefore an electro-pneumatic quick-acting valve was located near the cylinder and operated by a push button in the locomotive cab. Purple lights on standards located 75 feet in from each end of the track pans indicated when to lower and raise the scoop.

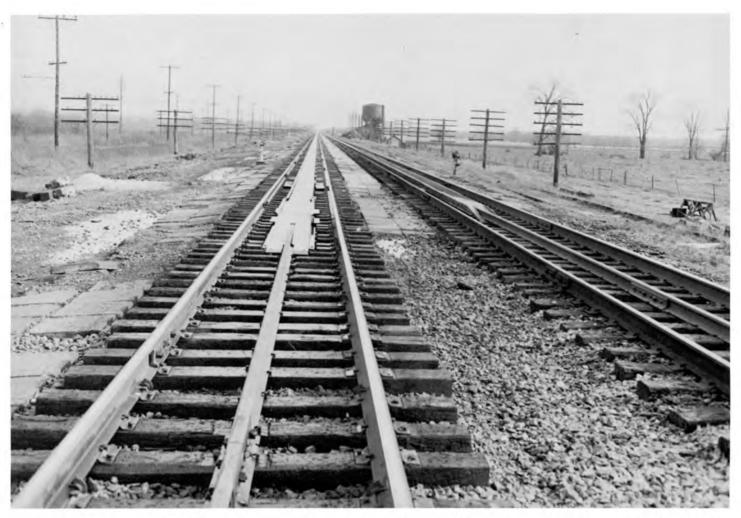
Looking east at Lydick, Indiana track pans, Track #1, November 20, 1945. Note the guard rail at the end of pan. NYCSHS

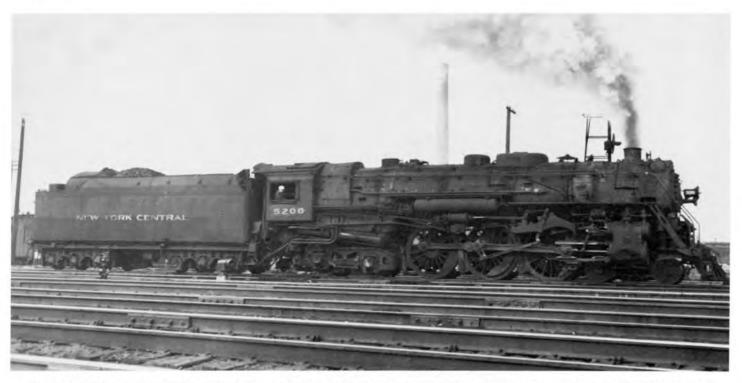
The first Hudson, J1a #5200, at Cheektowaga, N.Y. on February 3, 1952. Note that tender has had auxiliary surge tank applied, to rear of coal space. Photo by Joseph Brauner, C.M. Smith collection

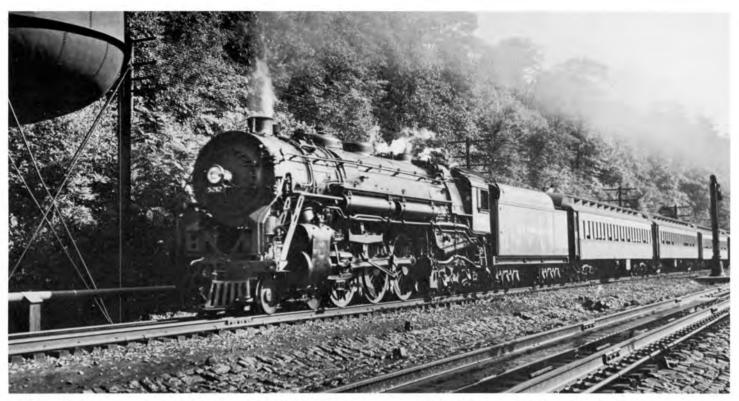
N.Y.C. J-1b 5212 at Tivoli, N.Y. approaching the track pans on August 30, 1941 with a Westbound extra train. Track pan shows up well in foreground. Edward L. May Collection

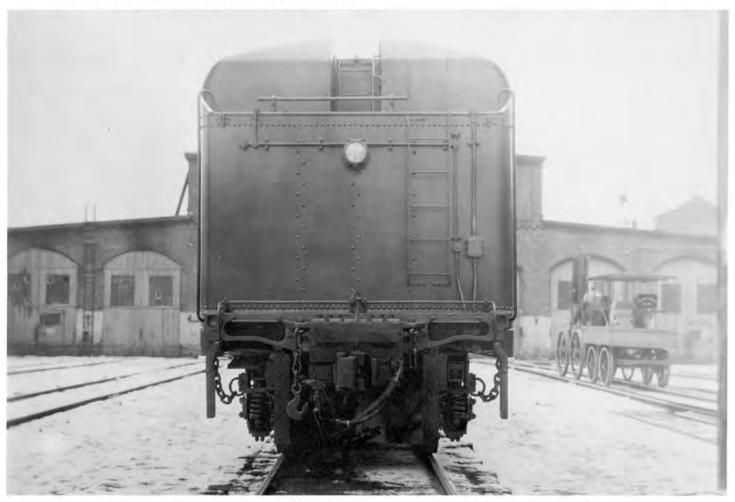
Rear view of tender, showing construction of the auxiliary surge tank back of the coal space. The "Dewitt Clinton" 1831 loco & tender on other track.

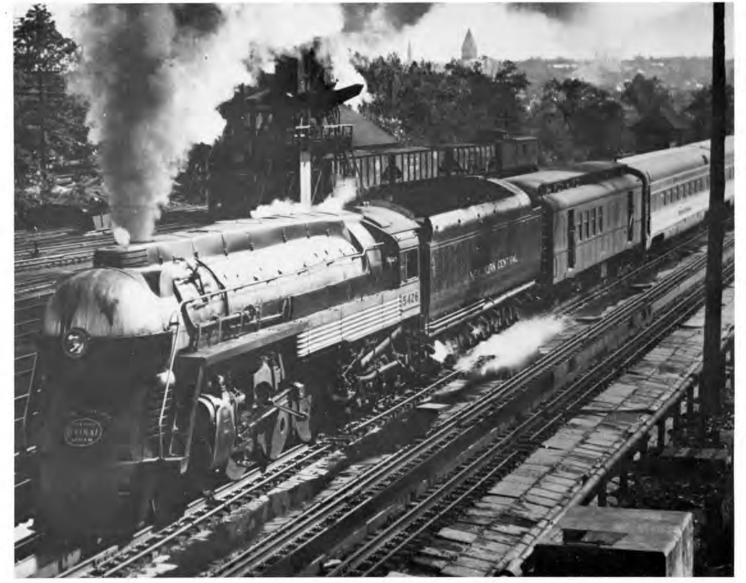
N.Y.C. 5426 with part of her streamline shrouding removed fills her PT-14 tender near Rennselear, N.Y. in 1947. Note track pan detail in near side track. Photo by Arnold Haas

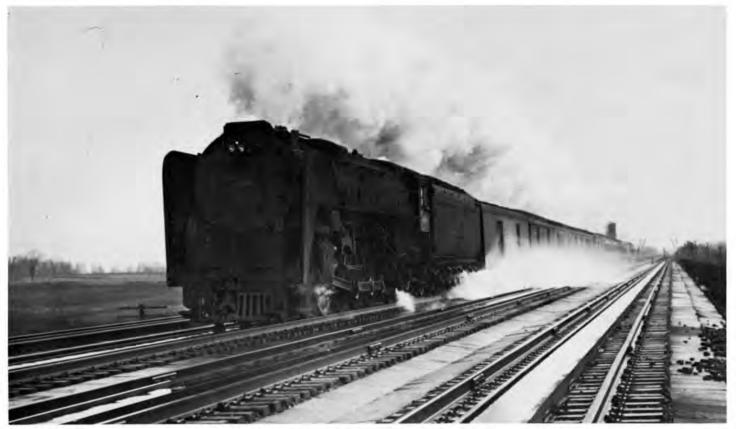
N.Y.C. Niagara 6020 with train No. 43 scoops water from the Silver Creek, N.Y. track pans on a rainy February day in 1949. Much testing and design work went into equipment to make this operation possible. Photo by H. L. Vail Jr.

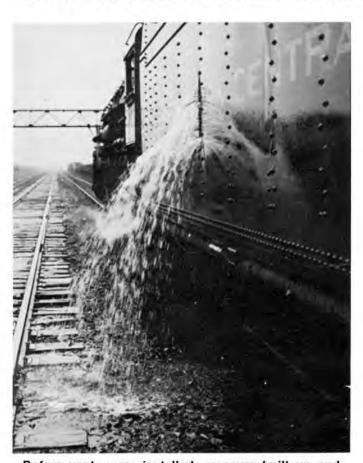
Before vents were installed, pressure built up and cracked the side of tender while testing the new design scoop.
